# ENVIRONMENTAL IMPACT ASSESSMENT

## Mammee River Development Project

For  
China Harbour Engineering Company Ltd (CHEC)

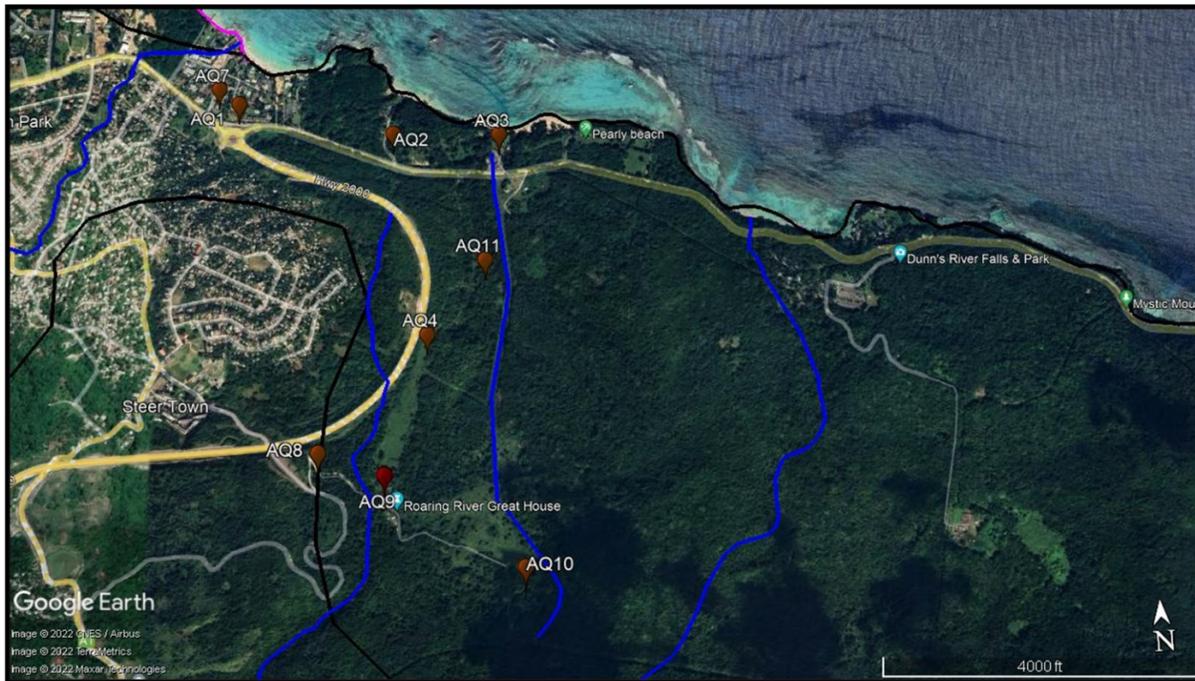
Figure 1-2: Air Quality and Noise Sampling Locations

Air quality sampling and noise sampling locations were taken at the same locations and are shown in Figure 1-2 below while water quality sampling locations are shown in Figure 1-3.

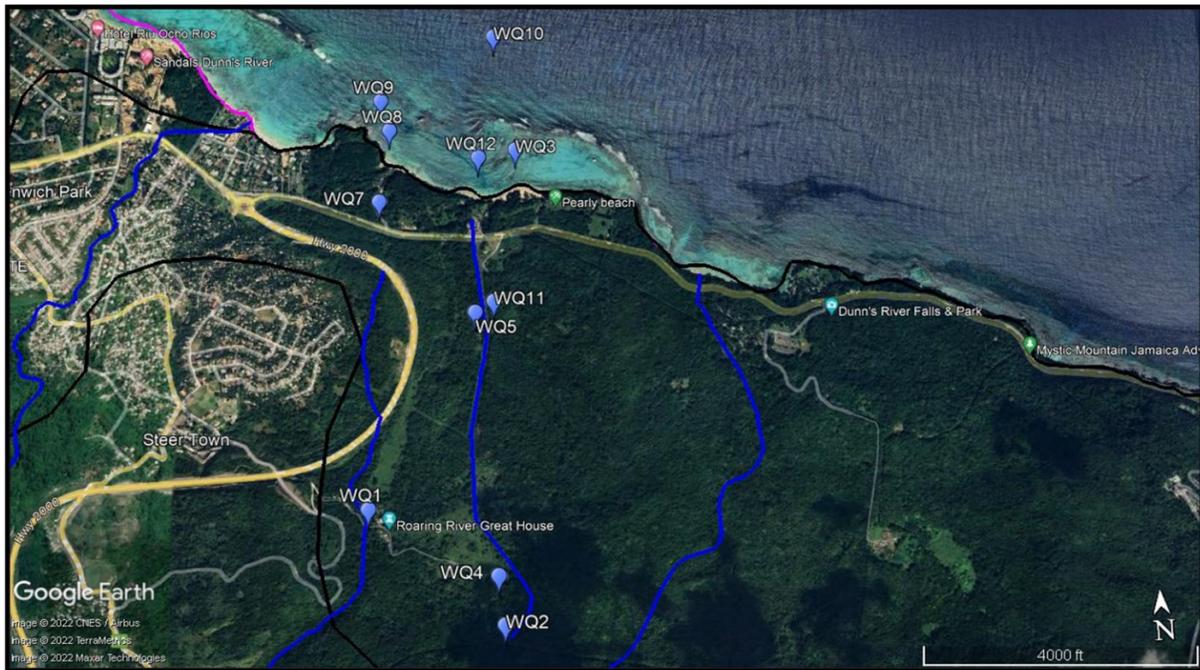
Figure 1-3: Water Quality Sampling Locations

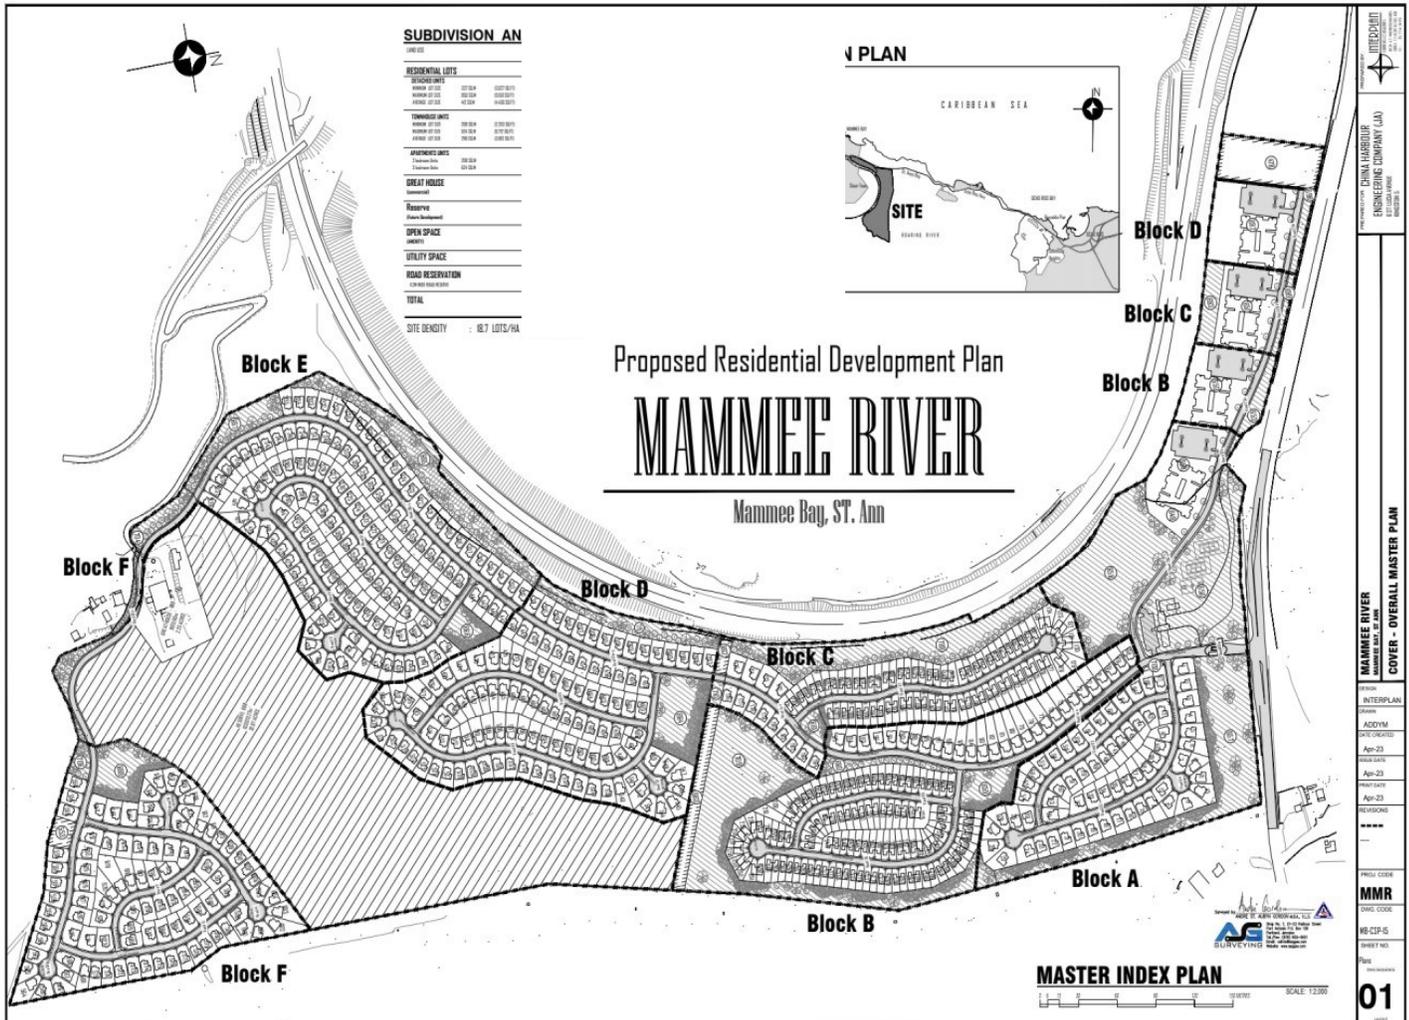
Figure 3-1: Master Development Plan

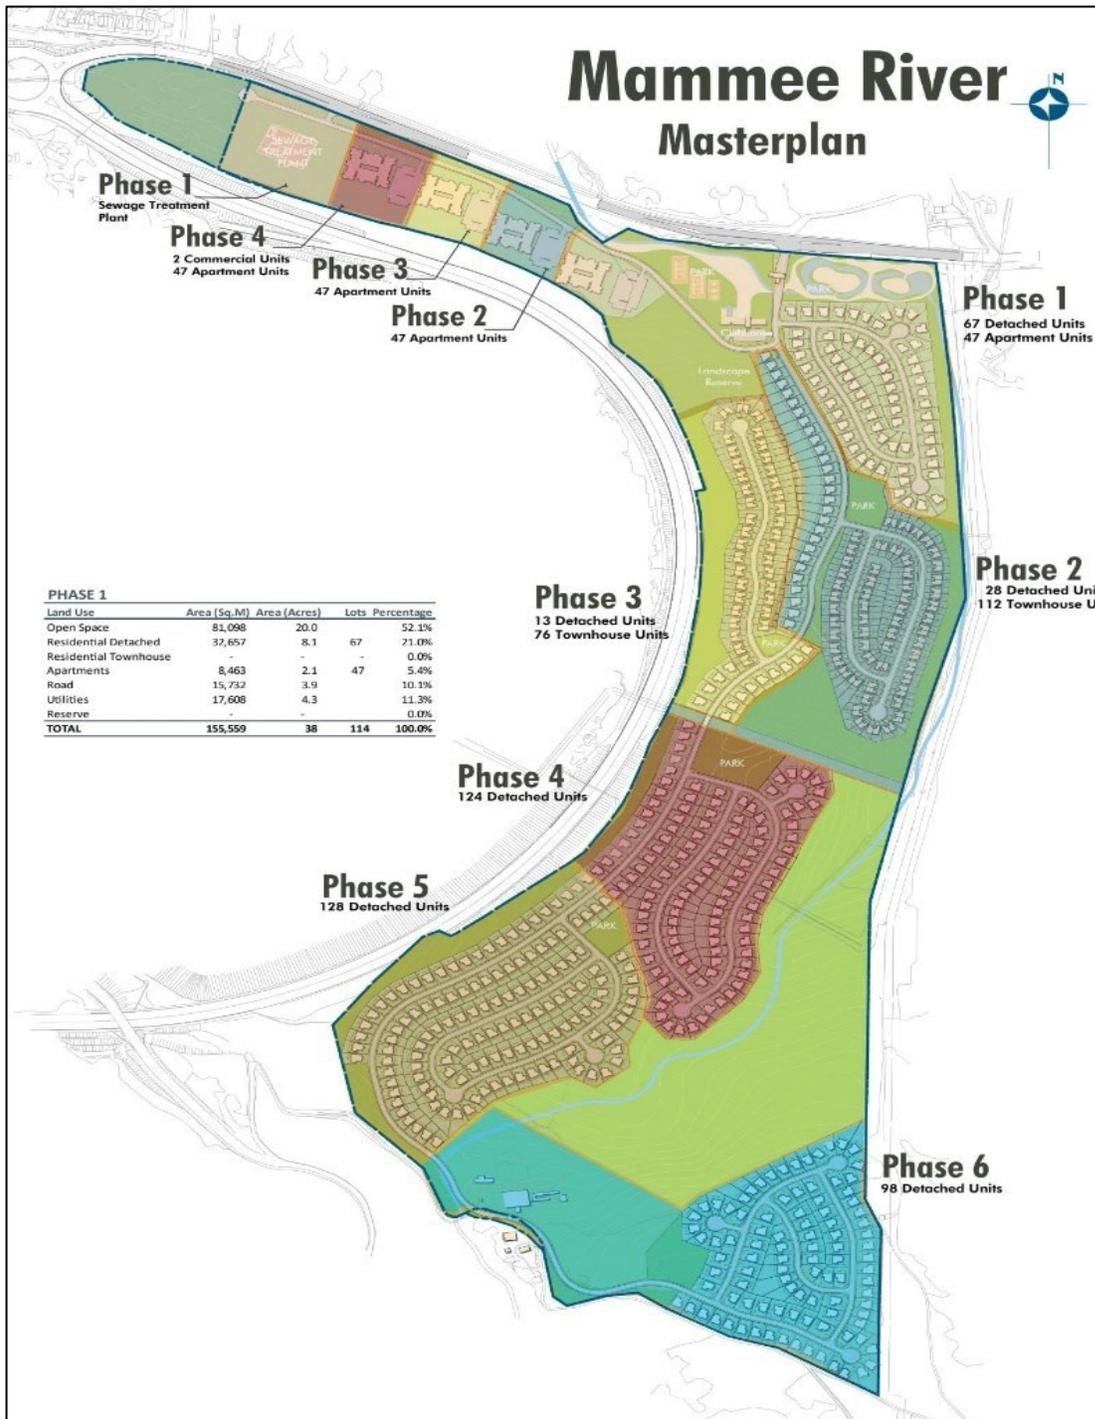
Figure 3-2: Site Layout plan and phases of development, as May 26, 2023

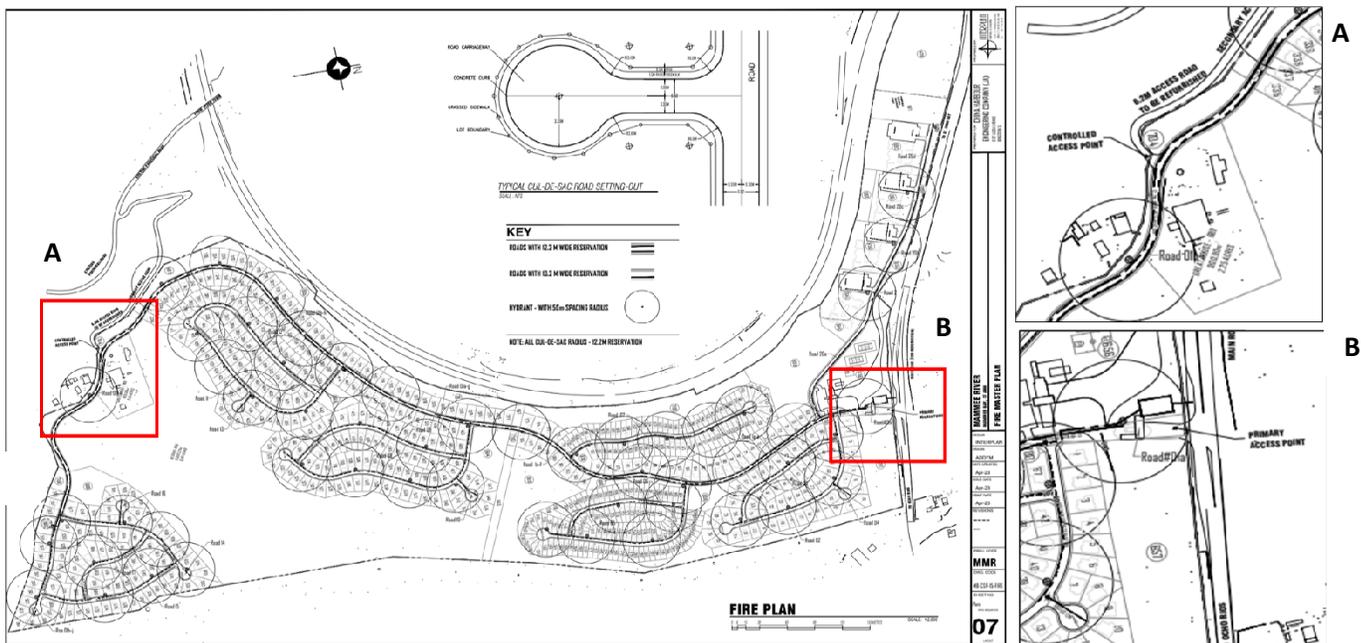
The subdivision has two access points. See Figure 3-15 below. The main entrance, point A, is located in the northern section, and the secondary access, point B is situated near the Greathouse in the southern section of the site. Both access points will be used during the construction phase and maintained thereafter. Upon completion of the first phase, the southern access will be utilized for all construction and operational activities.

Figure 3-15: Subdivision Access Points

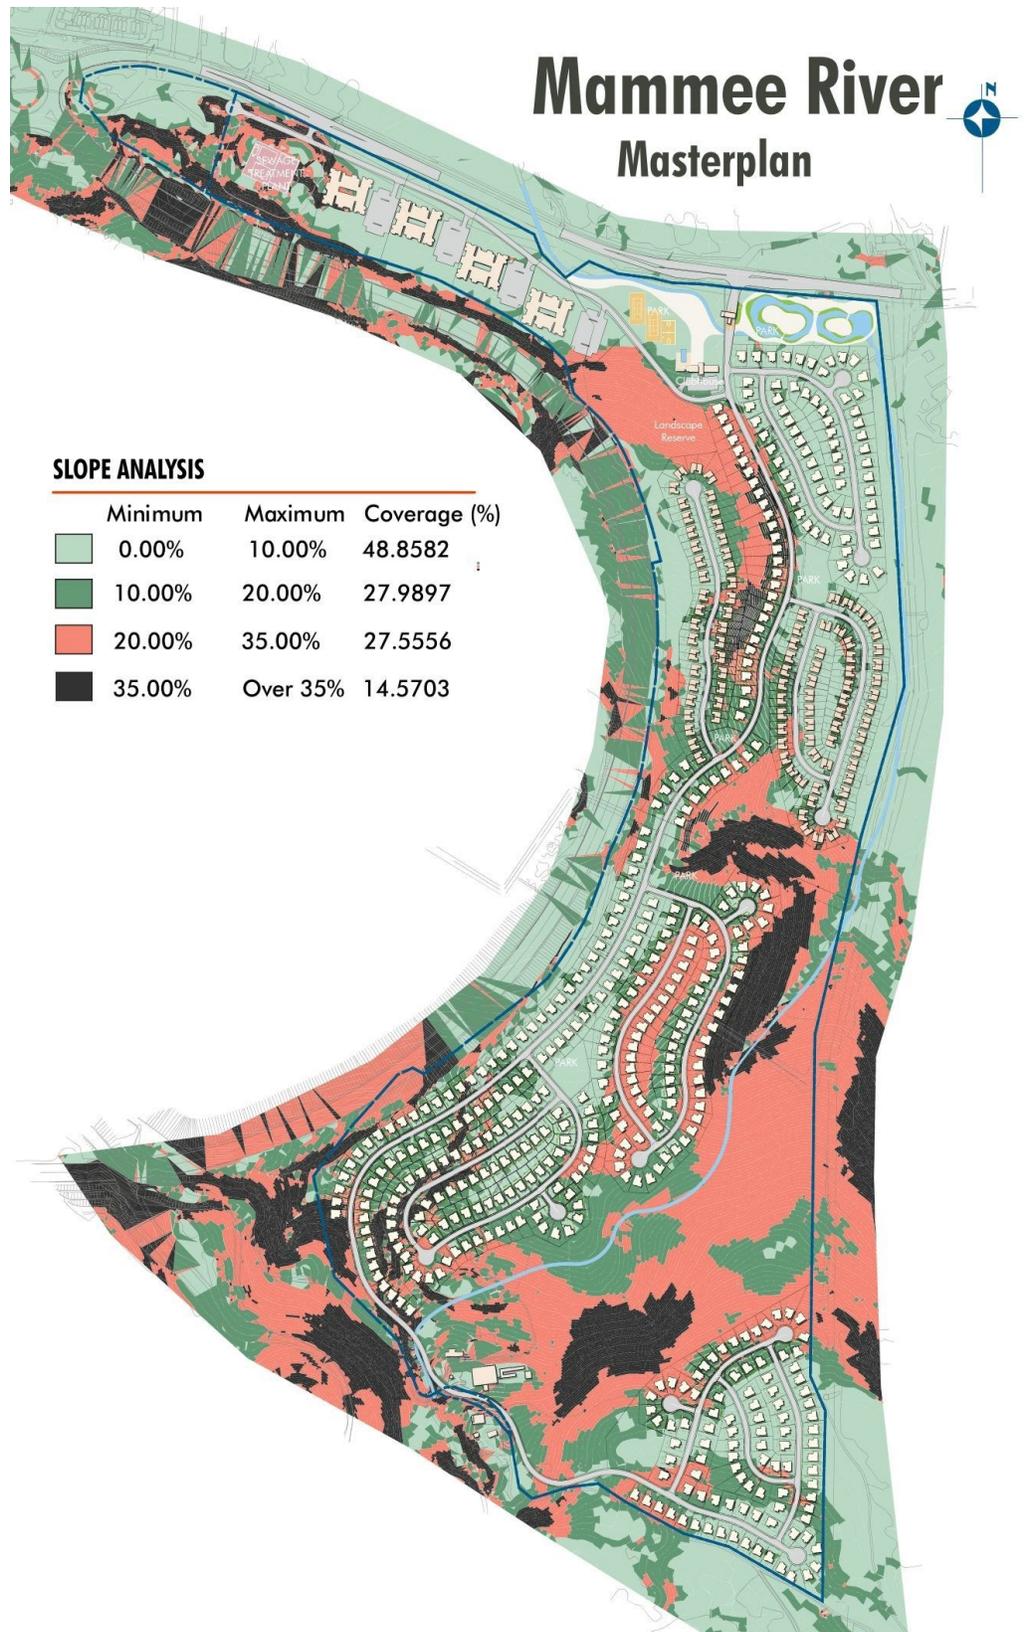
Figure 3-16 illustrates that 49% of the site is occupied by slopes less than 10% and will be the location of the majority of the construction.

Figure 3-16: Slope Analysis of Mammee River Development Project Area

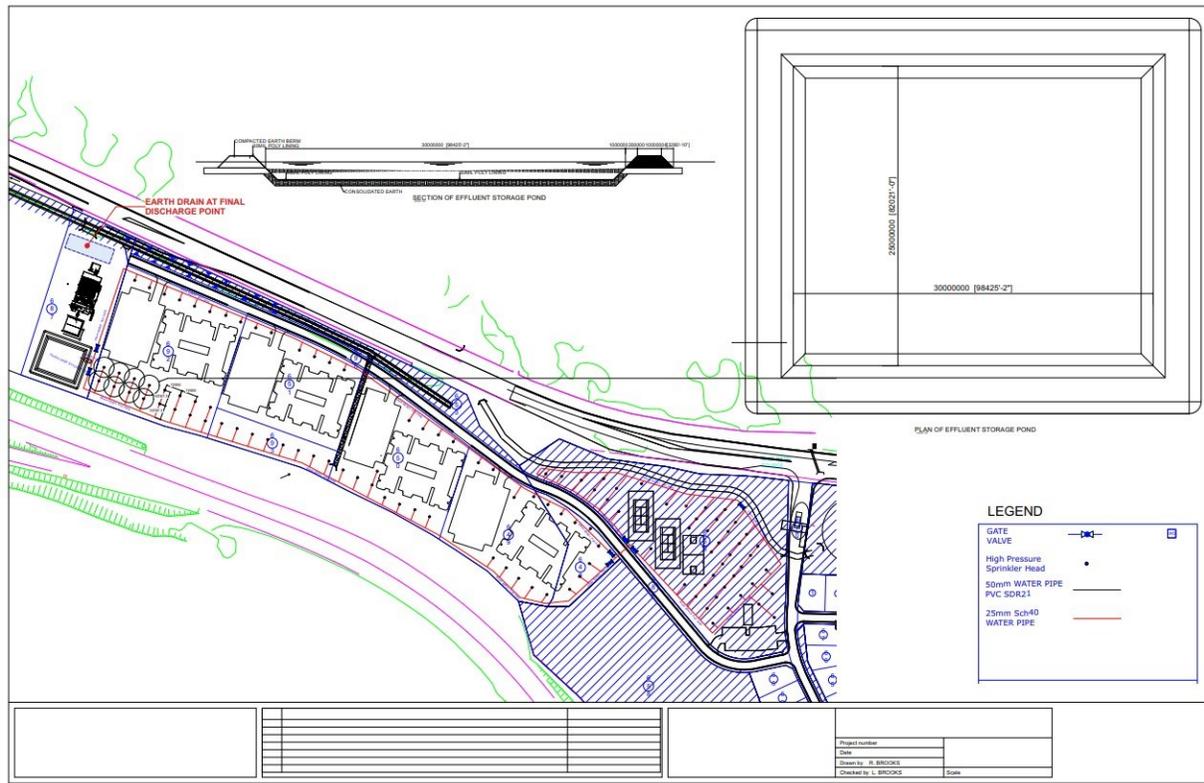
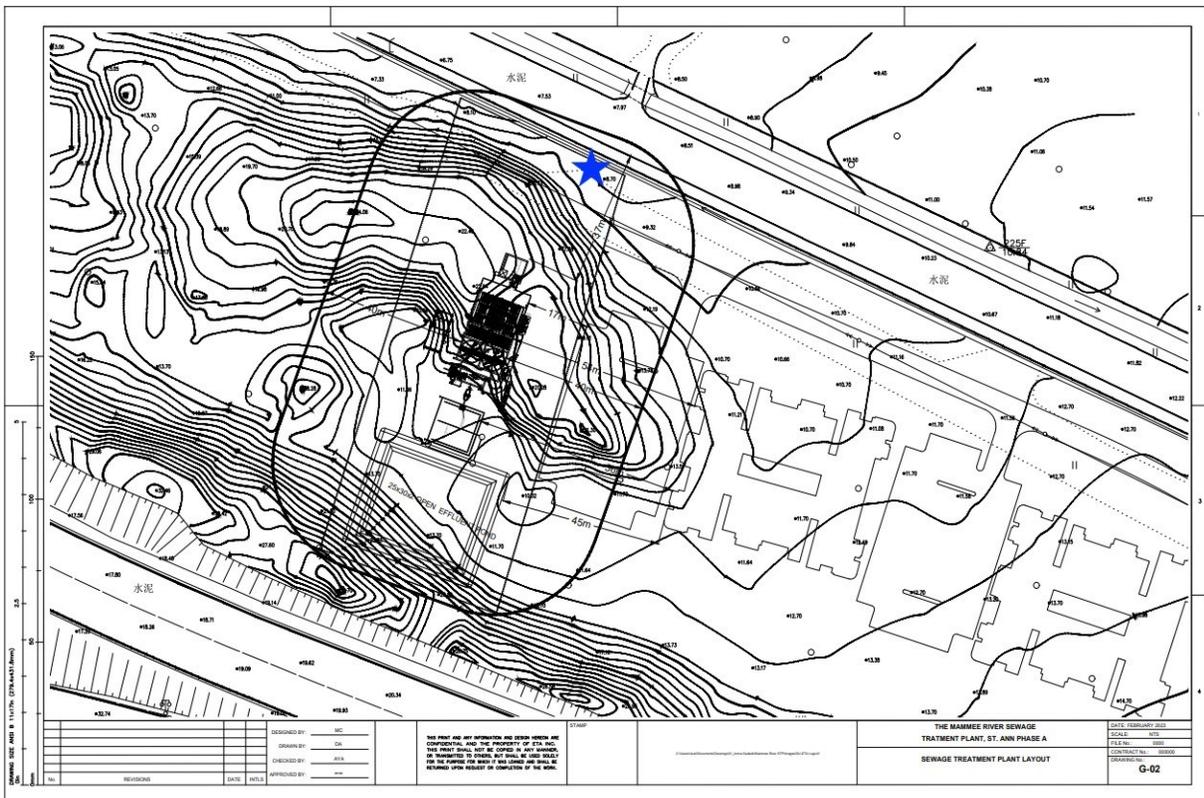
Figure 3-18: A) Discharge Point and Irrigation System B) Discharge point with setback distances

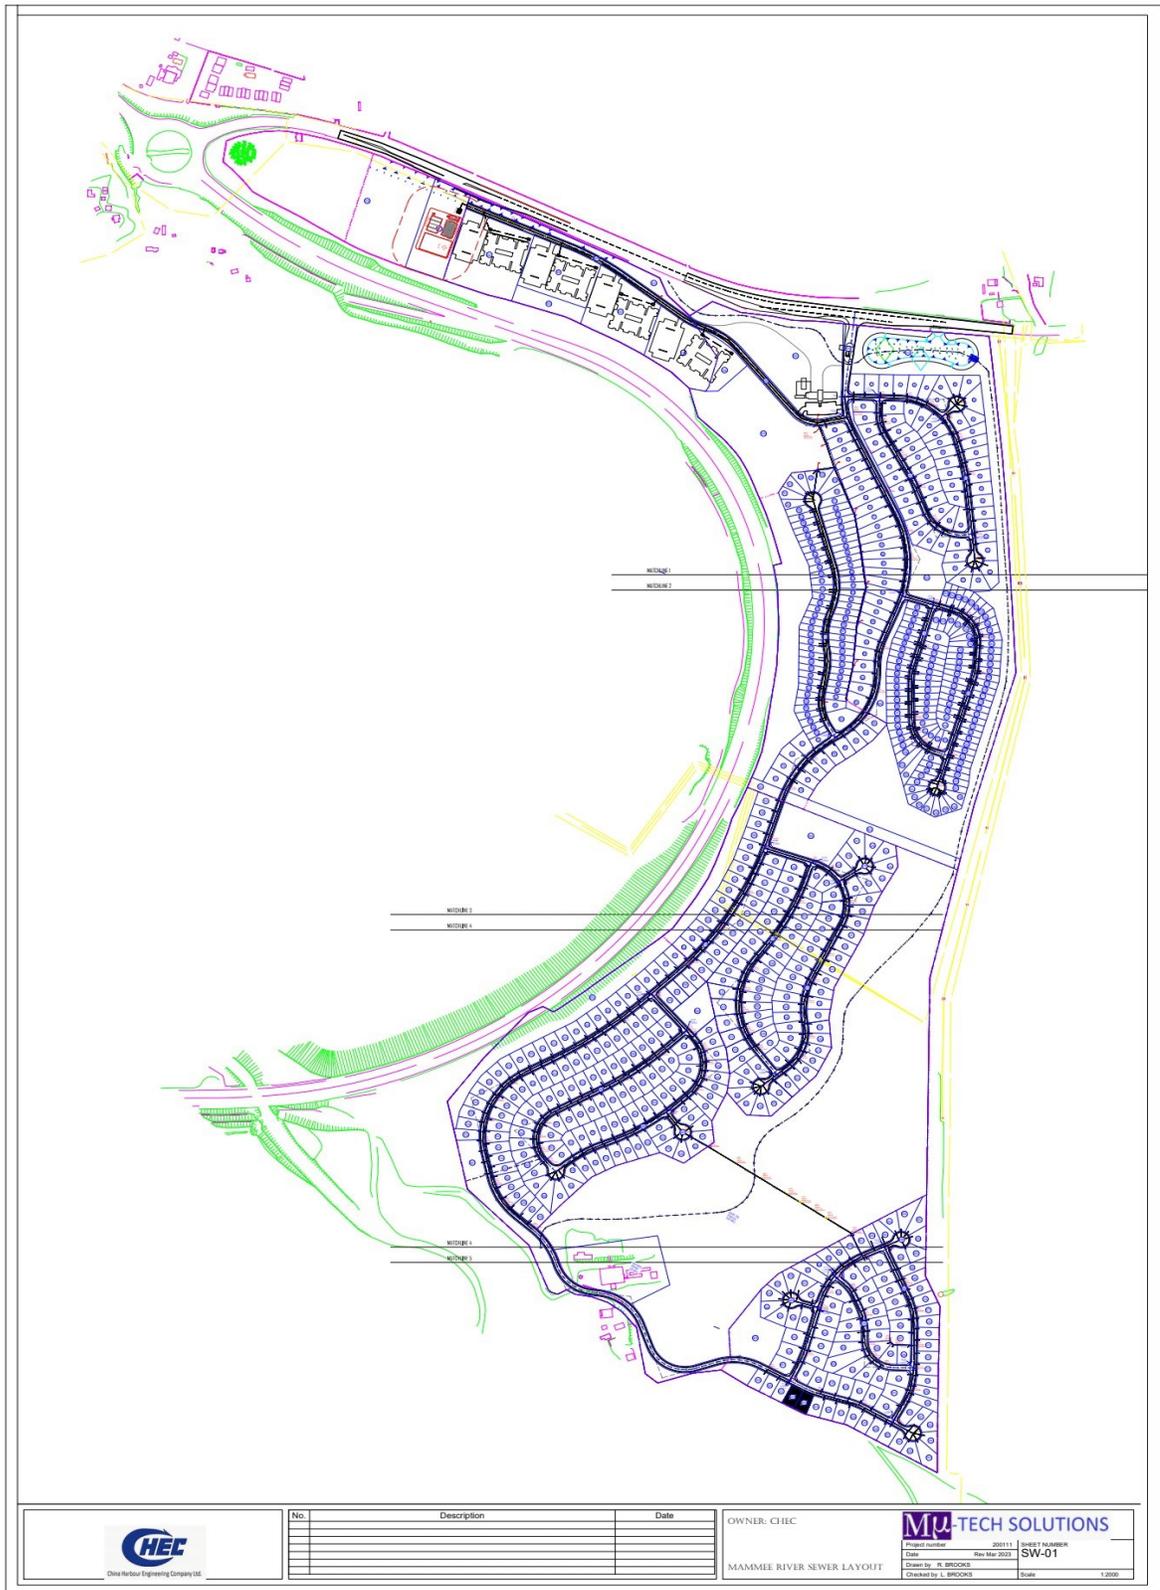
Figure 3-19: Sewage System Layout

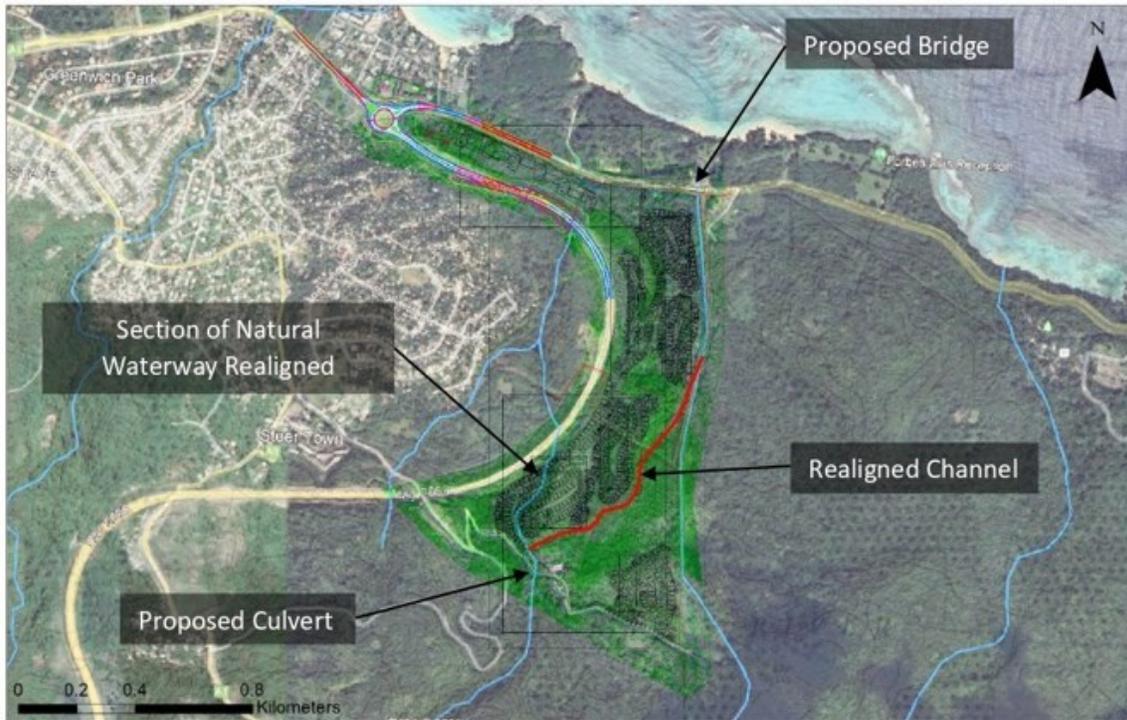
The proposed drainage plan involves a bridge that crosses the North Coast Highway, a culvert that crosses and existing local road within the subdivision, and the realignment of the upper section of the natural waterway. The drainage elements are highlighted in the figures below. See Appendix G for full drainage assessment report.

Figure 3-22: Proposed Drainage Features

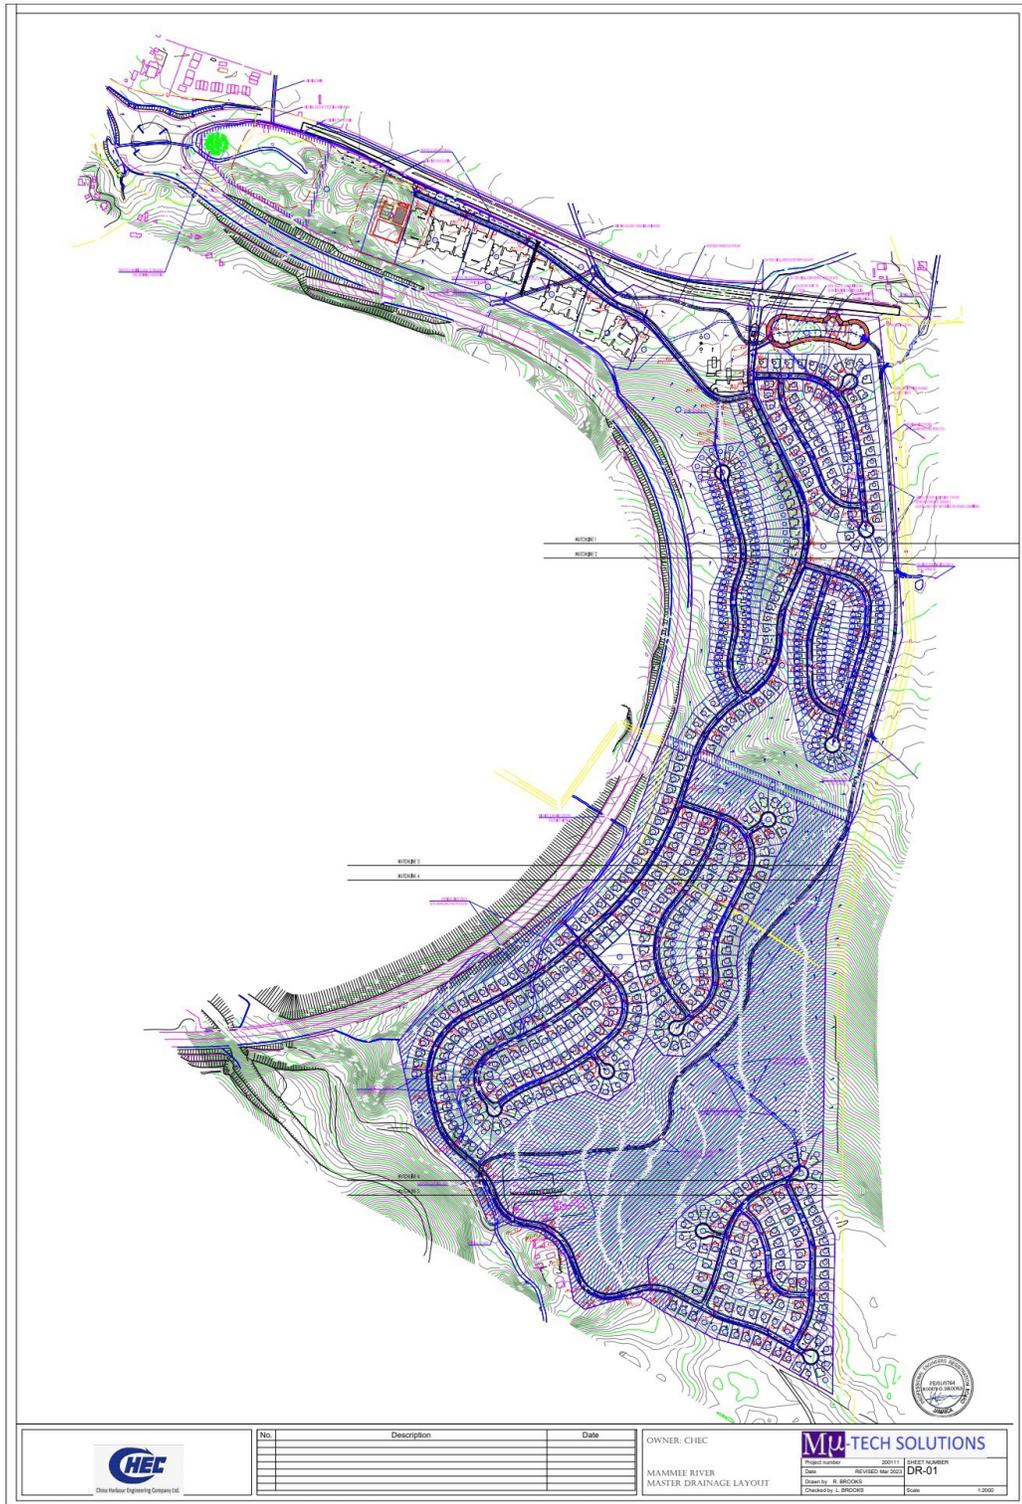
Figure 3-23: Drainage master plan

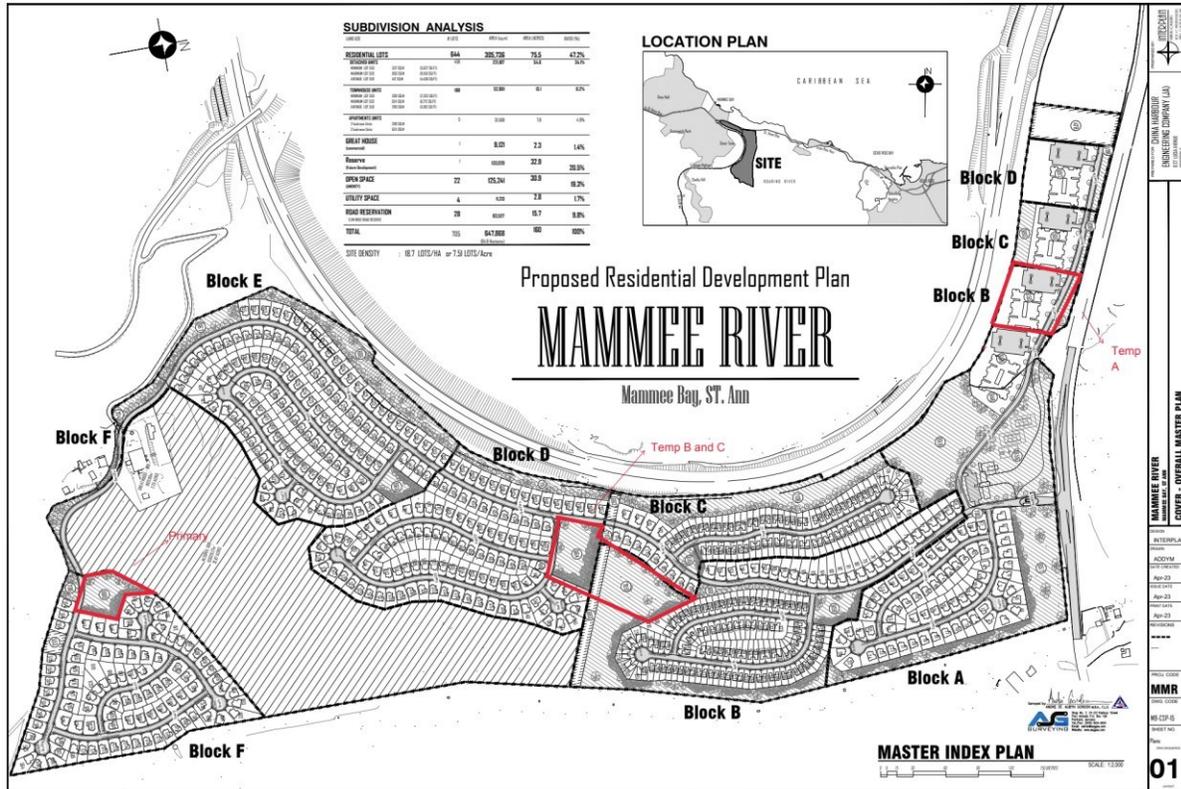
The aforementioned equipment and machinery will be stored on site in the designated areas: Temp A, B, and C, illustrated in Figure 3-24. It should be noted that a batching plant will be erected at the primary campsite, also highlighted in said figure, along with a block factory. An application will be submitted to NEPA for the erection of the batching plant.

Figure 3-24: Designated Work Areas and Storage Areas

Temporary accommodation for the workers will be provided in Temp A, B, and C areas highlighted in Figure 3-24 above. These facilities may include temporary dormitories, which are prefabricated, or modular buildings designed to house multiple workers. The facilities will feature sleeping quarters with bunk beds, common areas, dining facilities, and restroom facilities. It should be noted that the implementation of these facilities will be done in phases.

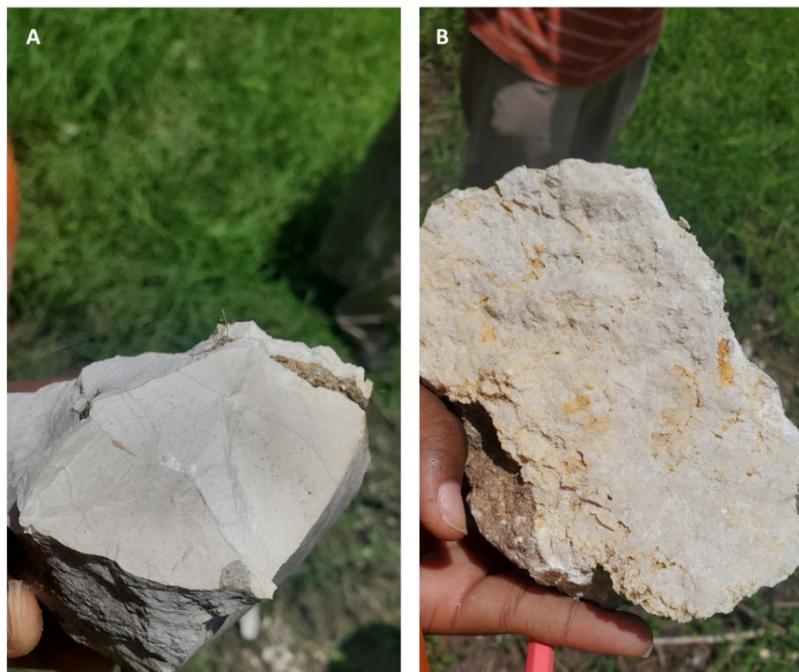
During the site reconnaissance grainstone<sup>1</sup> textures of the Montpelier Formation were observed, according to the Dunham classification (1962). Limestone with dull chalky texture<sup>2</sup> was also observed during the site reconnaissance. These rocks were observed within the southern sections of the project site (see Figure 4-2).

Figure 4-2: A) Limestone with dull chalky texture observed on site B) Grainstone limestone observed on site

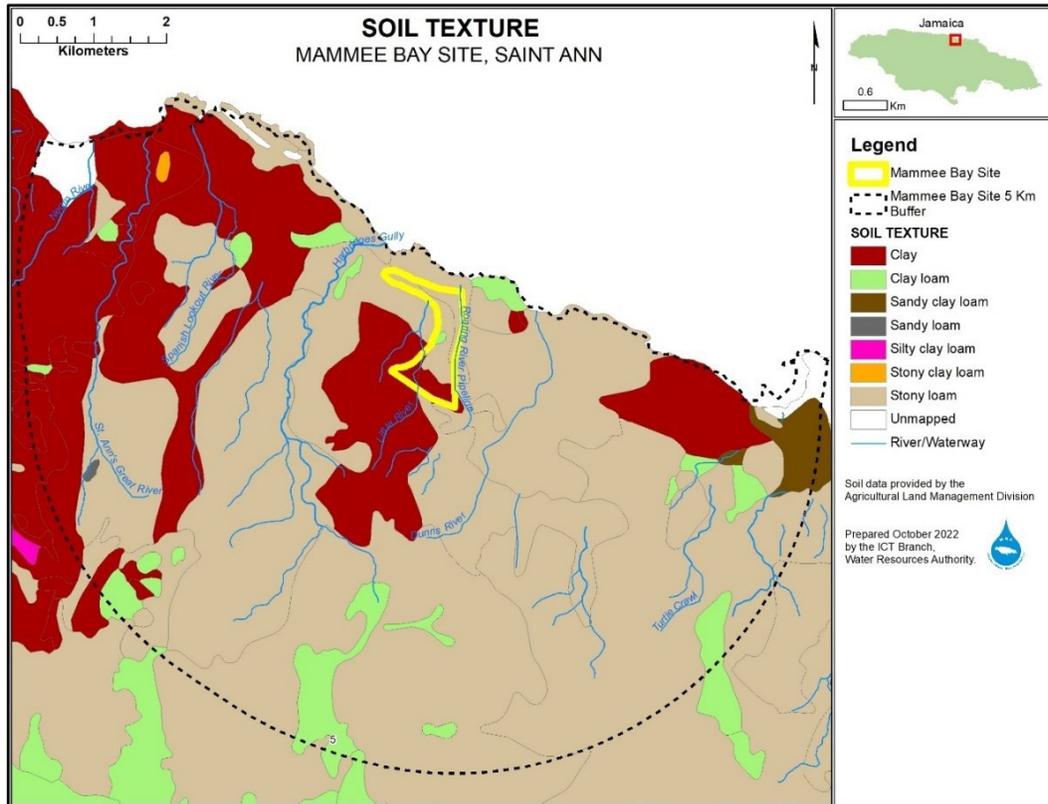
Figure 4-4 illustrates the soil texture within and surrounding the proposed project site. The proposed site has three (3) soil textures: stony loam, clay loam and clay with the main texture as the stony loam. During the site reconnaissance visit, stony loam, with subangular to subrounded pebble and granule size limestone clasts were observed within the southern sections of the site.

Figure 4-4: Soils Map (Source: WRA)

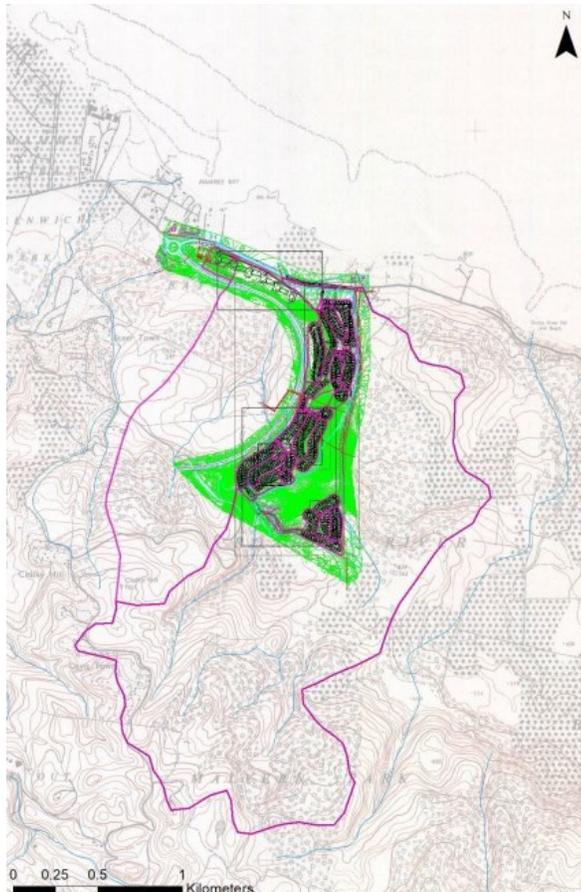
Figure 4-6: Pre-Development offsite watershed areas

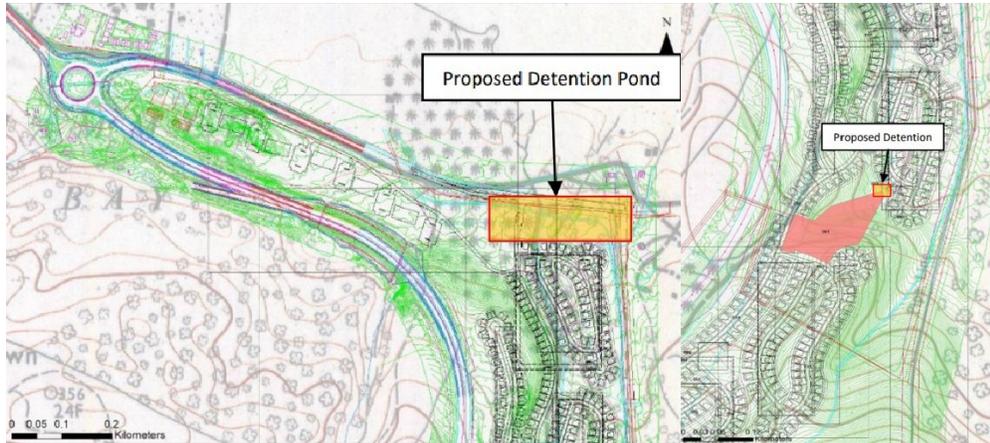
Figure 6-1 Proposed location of detention ponds
