ENVIRONMENTAL AND SOCIAL ASSESSMENT FOR PROPOSED HOUSING DEVELOPMENT- CORAL SPRING VILLAGE 2 TRELAWNY

Resubmitted: October 14, 2024

Draft Final Report

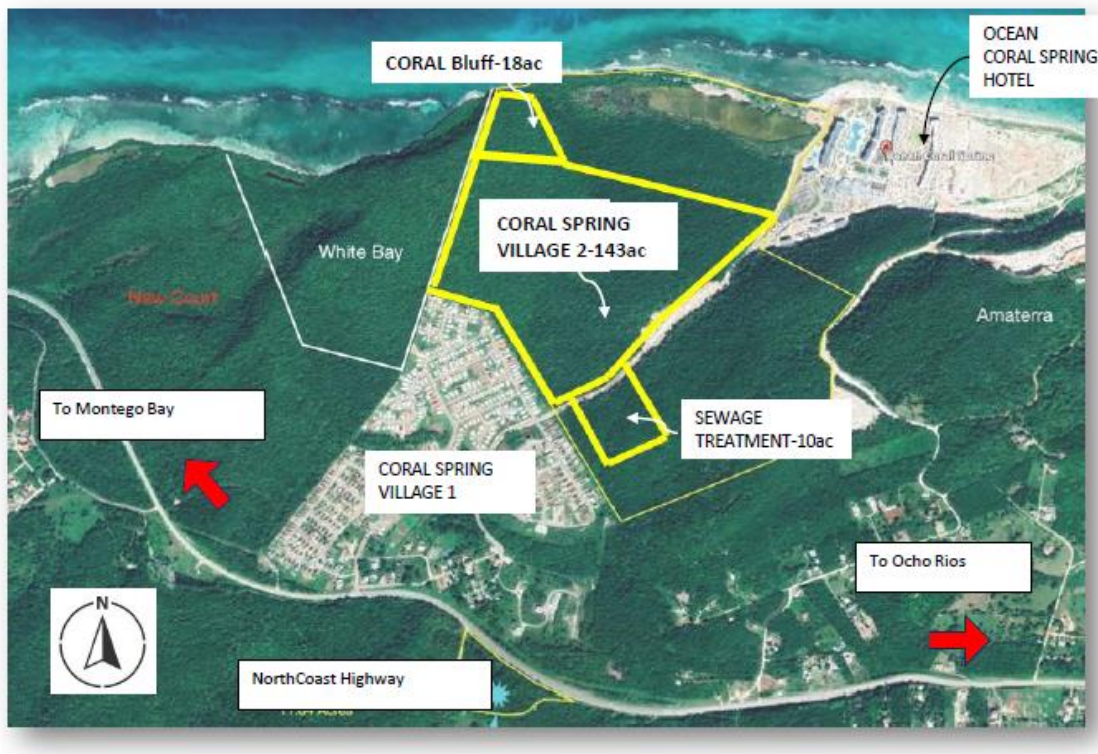
Figure 1: Location of Proposed Development Site

The site is located about 7 km due east of the town of Falmouth and 7.5 km due west of Duncans, Trelawny. It is bordered by the Coral Spring-Mountain Spring Protected Area (CSMSPA) to the west and the existing Coral Spring community to the south. The proposed development site spans approximately 0.7 km² with a perimeter of about 3.22 kilometers and is located in close proximity to the North Coast Highway and Ocean Coral Spring Hotel.

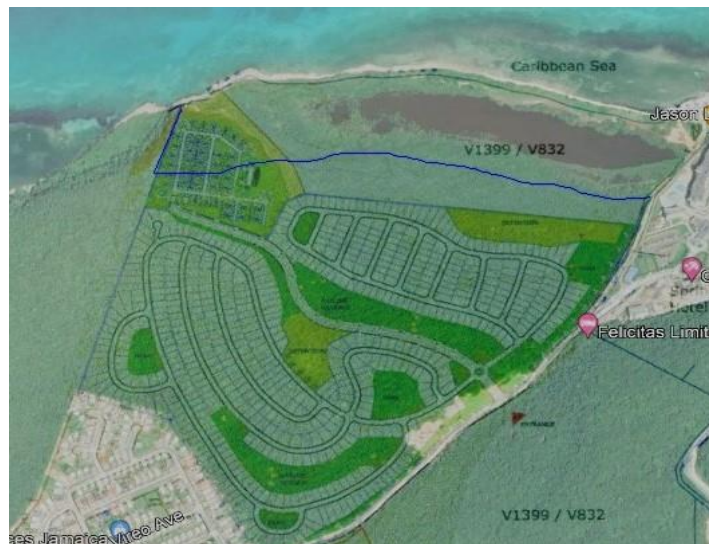
Figure 1-1:(a) Preliminary subdivision plan with conservation overlay

Gore Developments Ltd (GDL) proposes to extend the existing Coral Spring Village housing development in Trelawny. The proposed expansion, known as Coral Spring Village 2, will comprise approximately 600 detached housing units and will be situated adjacent to the existing Coral Spring 1 development (see Figure 1-1). This expansion aims to address the growing demand for housing on the north coast of Jamaica, while adhering to sustainable development practices. The project's proximity to the Mountain Spring Protected Area necessitates careful consideration of potential impacts on local flora and fauna. Concerns regarding ecology, hydrology, drainage, water quality, and coastal threats underscore the importance of comprehensive environmental assessment and mitigation planning. It is significant to note the need to meet national / regional housing needs as well as the setting of the development within the north coast resort development corridor and its proximity to other existing and proposed developments.

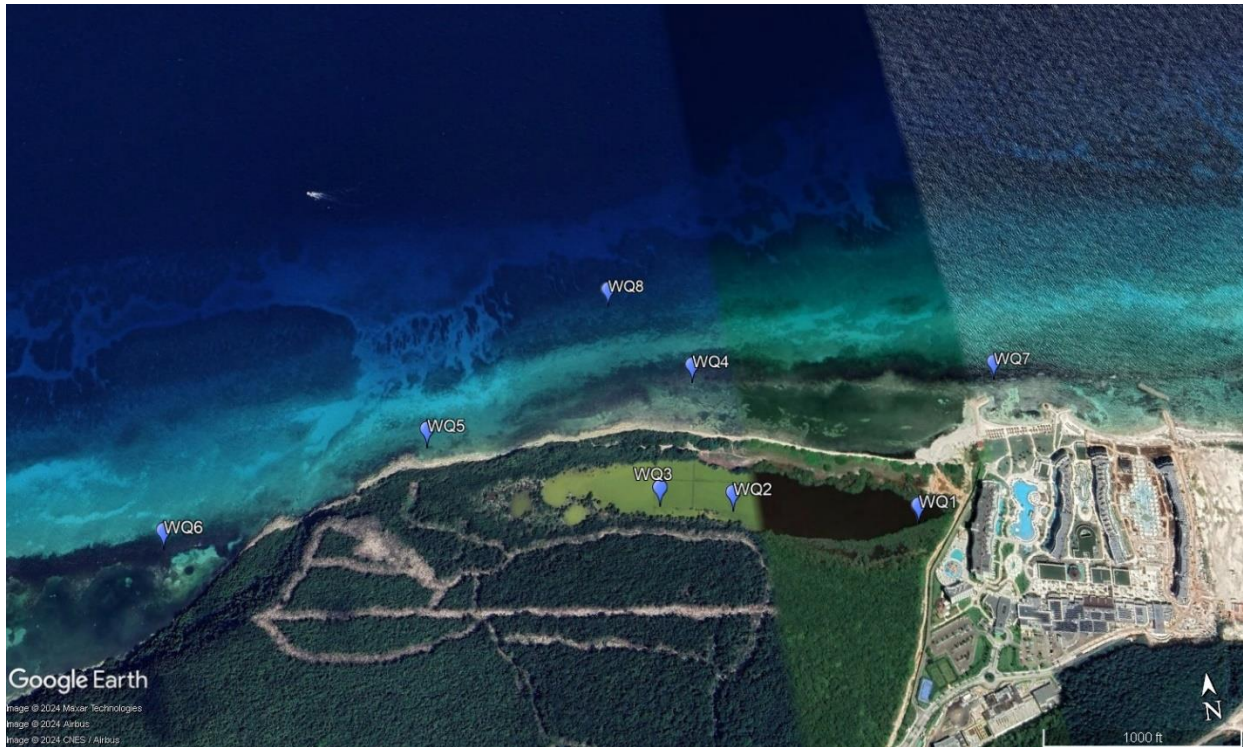
Figure 1-5: Water Quality Assessment Points

Sample locations are shown in Figure 1-5 below, while the findings and description of each water quality location sampled are presented in section 4.1.7..

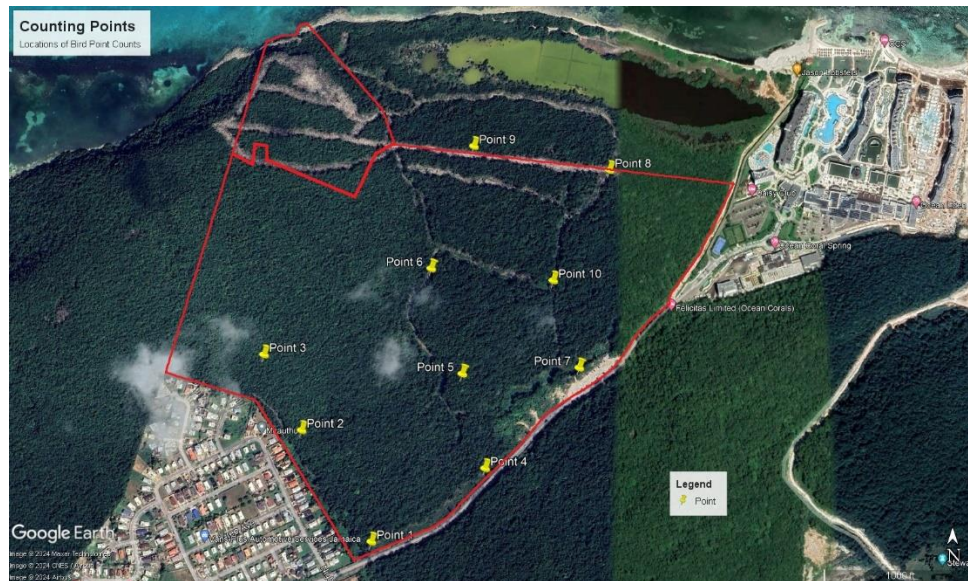
Figure 1-7: Animal Sampling Points

The collected data were analyzed to identify trends in species distribution and abundance. Maps and charts were created to visually represent the findings, highlighting areas of high faunal diversity and the presence of endangered or protected species. The results were then integrated into the overall ecological assessment for the project area.

The proposed wetland area for conservation within the sphere of influence of the development was surveyed between March 21-22, 2024. The mangrove forest was accessed using the roadway to the Coral Spring Hotel. The area was sampled by collecting data from 10 (10m x 10m) sample plots/quadrats (see Figure 1-7).

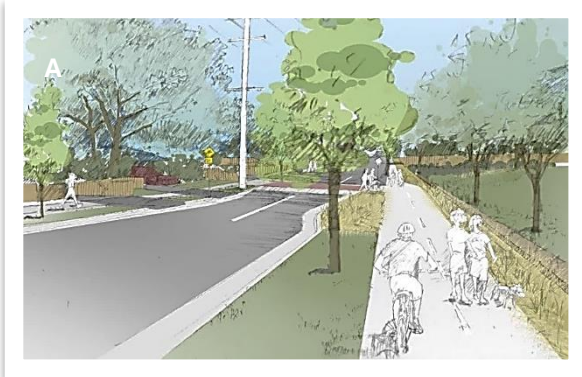
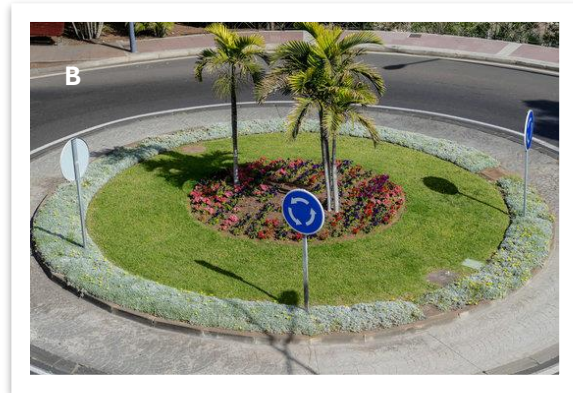
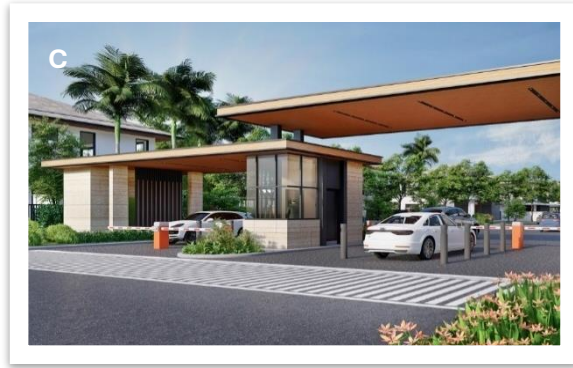
Figure 3-1: (A) Central Boulevard (B) Landscaped Round-a-bout (C) Entrance

A spacious detention area is included in the design to provide open space, and the natural vegetation will be preserved in all open areas where possible. Additionally, a plant nursery will be established to propagate new seedlings and local trees from the site for the newly landscaped areas and parks (see Figure 3-1)

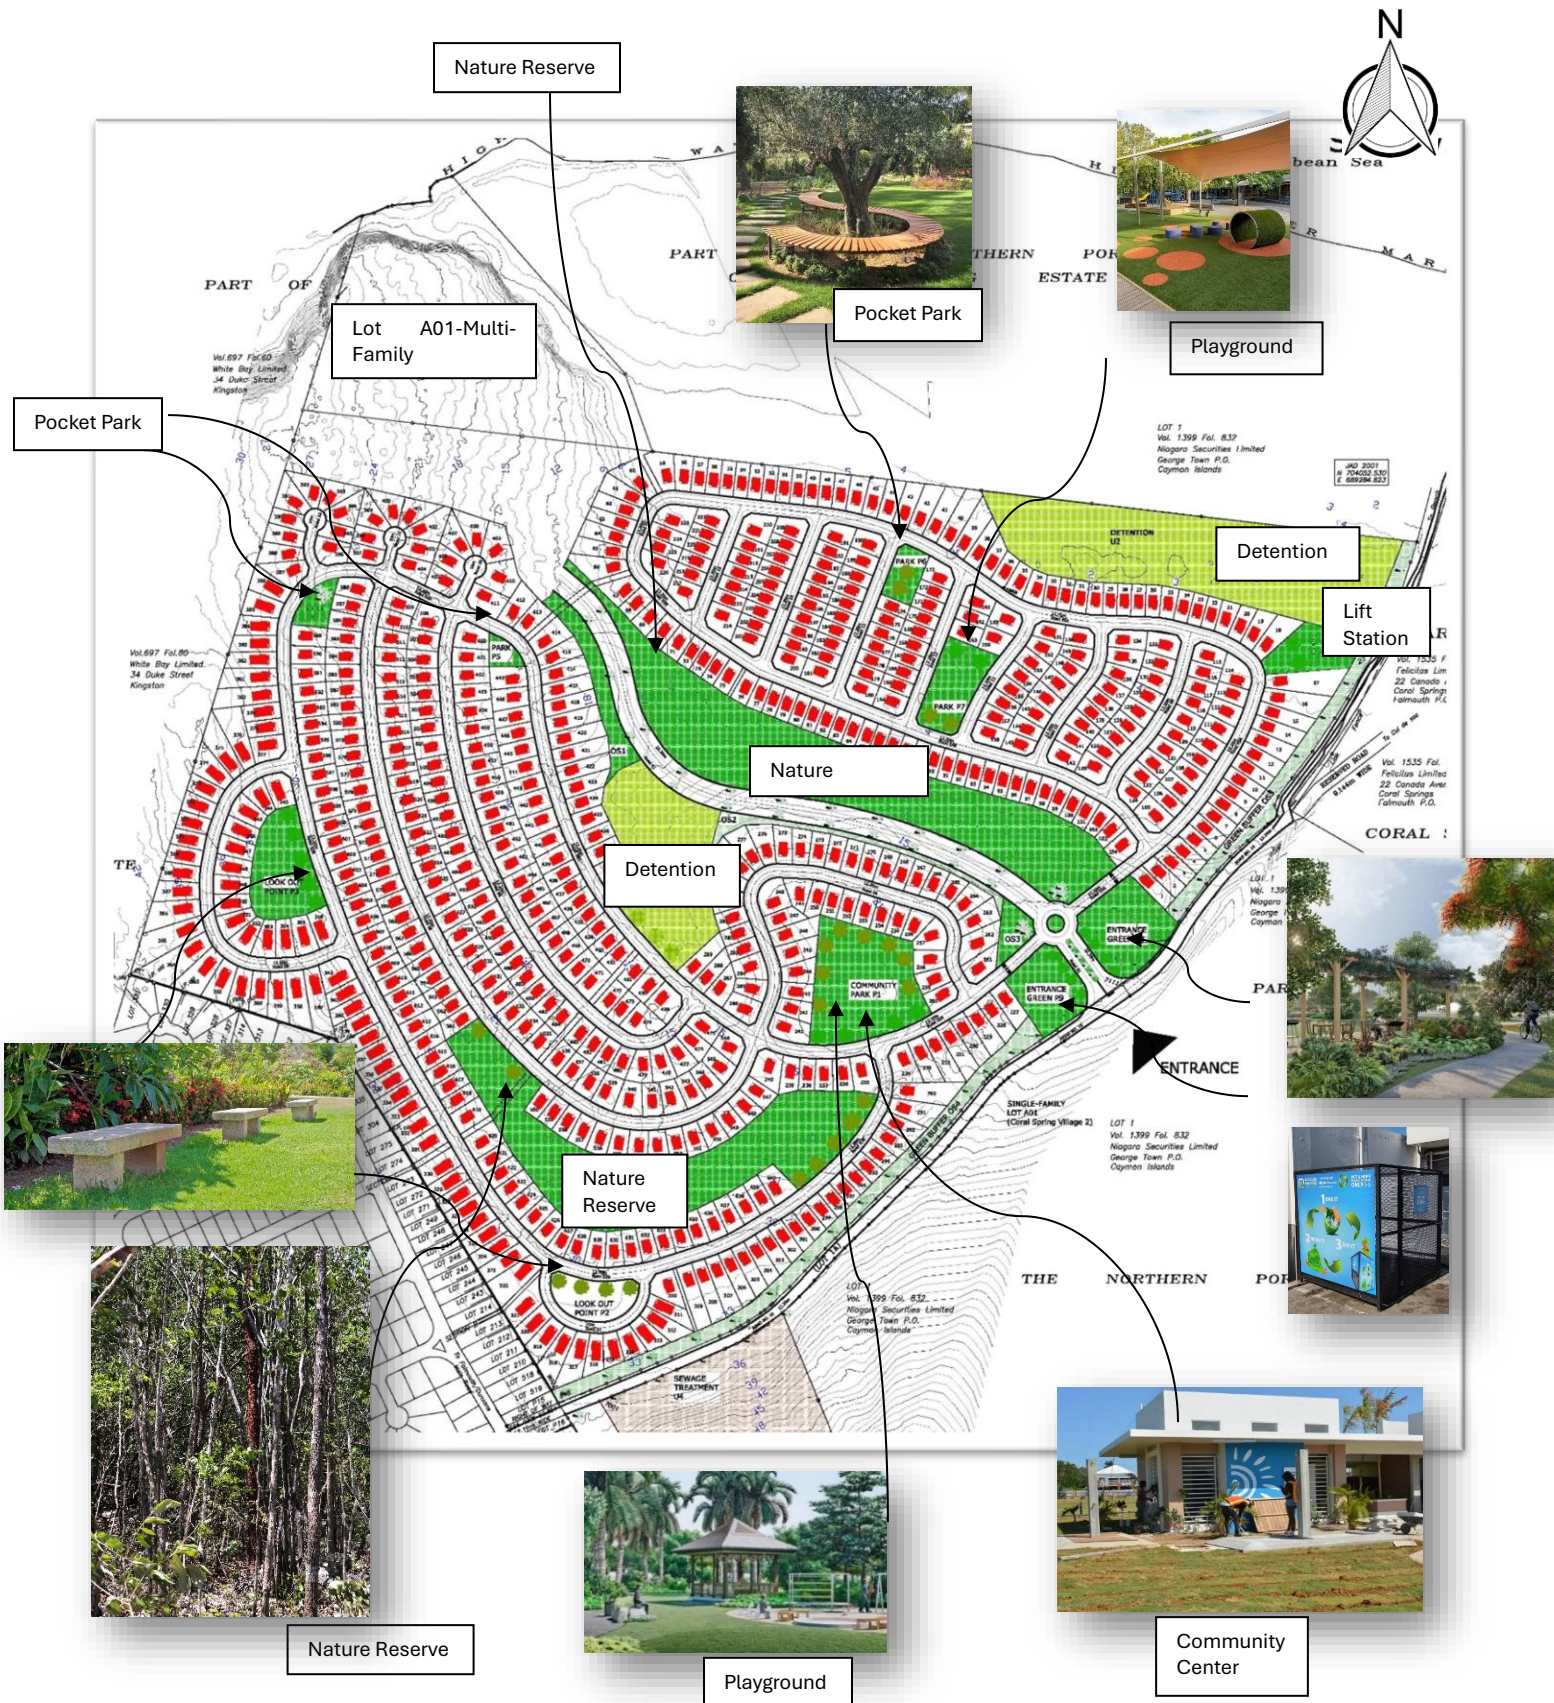
Figure 3-3: CSV II Preliminary Landscaping/ Open Space Design

The landscape design for the Coral Spring development prioritizes the integration of native and endemic species identified in this EIA. The development plan includes significant open spaces, parks, and nature reserves to enhance the community's livability and ecological value (see Figure 3-3). For the 660 proposed lots, a total of 66,759 square meters of open space is required. However, the actual open spaces included in the project amount to 104,359 square meters, significantly exceeding the minimum requirement. This generous allocation of open space ensures ample recreational areas and preserves natural habitats, fostering a harmonious relationship between the built environment and the local ecosystem. Table 3-5 below provides a detailed breakdown of the open spaces included in the project while Figure illustrates the proposed distribution of these spaces.

OPEN SPACES	21,511.585	5.316
	PARKS	32,293.338	7.980
	NATURE RESERVE	50,554.199	12.492
	Total:	104,359.122	25.788
Open Space requirement:			
	for 660 lots	66,759.000	16.50

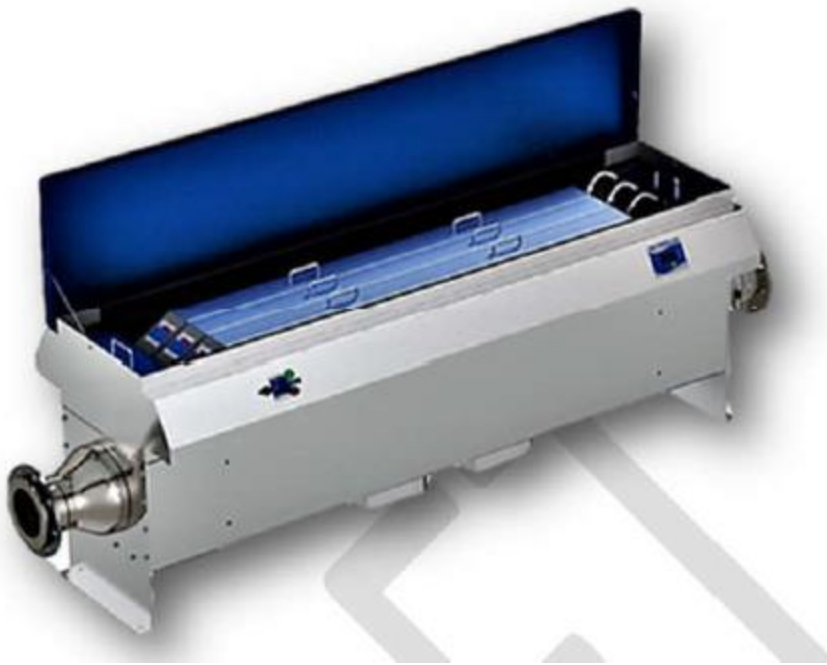
Figure 3-9: Enaqua UV Disinfection – M5 Series

This component of the facility is responsible for removal of pathogens (disinfection) and allows the treated wastewater to be disposed of safely into the environment. The Enaqua non-contact M5 series has been chosen for this location (see Figure 3-9). It can treat a flow rate of 81.8 m³/h which is in excess of the estimated peak flow rate from the lift station.

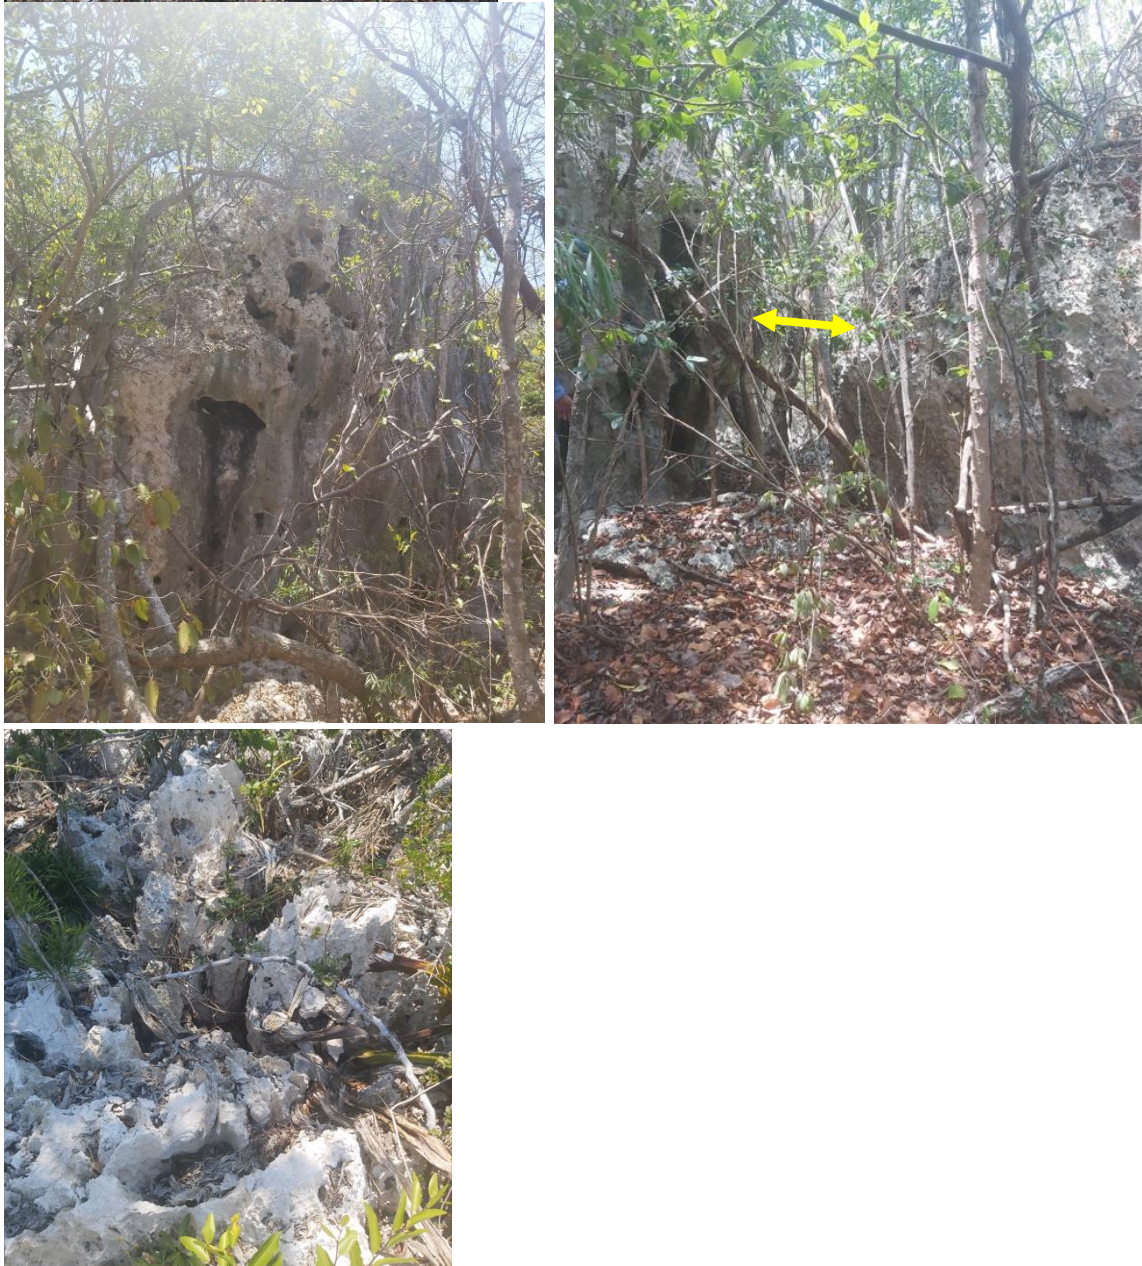
Figure 4-2: Karst Features Observed at Project Site

The project area is situated within the North Coast Belt. The geomorphology of the northern coast of Jamaica consists of raised reef terraces, beaches, bays, and headlands. The project site comprises a low-lying limestone platform, fault-influenced bluff, and karst features. Karstic features such as mature karst, small cavities, voids, fractures, and other dissolution features were observed in the limestone outcrops and on the northwestern areas of the site. Additionally, in the northwestern areas, there was an increase in the number of voids, more visible interconnectedness of the voids, presence of dissolution features and fractures along the surface of the joints and pinnacle karst at the edge of the bluff. Limestones mapped towards the central and eastern sections of the site are characterized by highly irregular surfaces penetrated by hollow dissolution cavities, sharp points, and pits. Cavities do not prohibit development and can be managed. However, the dimensions, interconnectedness and strength and structural integrity cannot be determined until the site is cleared.

The project area features karstic terrain with mature karst, small cavities, voids, fractures, and pinnacle karst. Karst features include dissolution cavities, sharp points, and pits, particularly in the central and eastern sections. Cavities can be managed with proper engineering solutions like grouting, raft foundations, geogrid, or piles. Two caves, Stewart's Cave and Johnson's Cave, are located within 500 meters southeast of the site. A small collapsed cavern observed in the north-central part requires further investigation during site clearance.

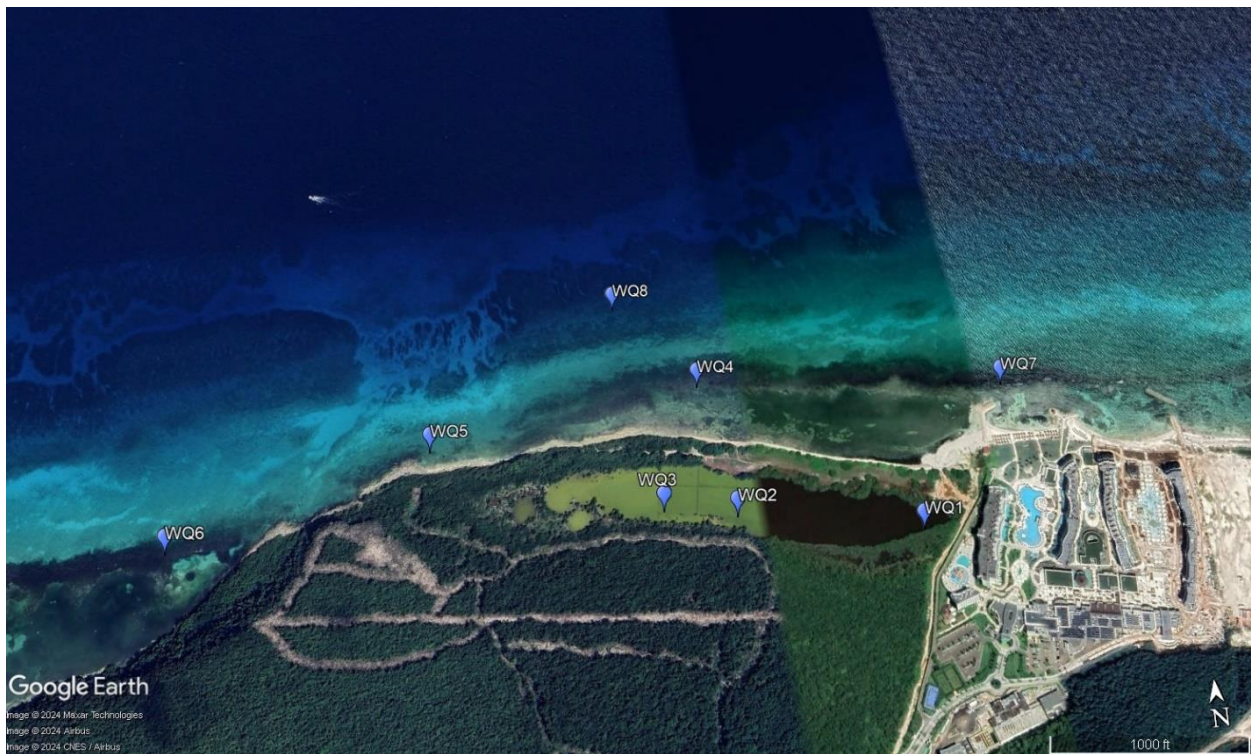
Figure 4-16: Water Quality Sampling Locations

Based on the results obtained from the samples collected during the time of assessment, all samples could be classified as saline or highly saline water samples. Saline samples exhibit salinities between 33 and 38 ppt while hypersaline samples are those that have salinities above 38 ppt.¹ In the dry season, sampling points WQ1 - WQ3 were classified as hypersaline water while sampling points WQ4 – WQ8 were classified as saline or marine water samples (see Figure 4-16: Water Quality Sampling Locations). However, in the wet season, all samples could be classified as marine or saline samples.

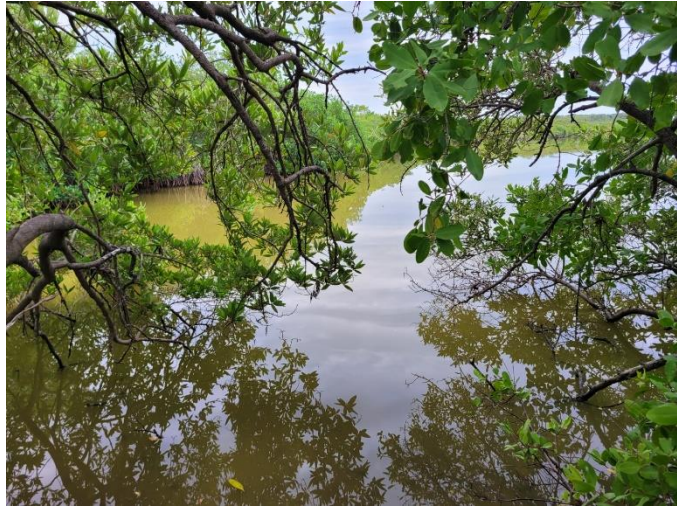
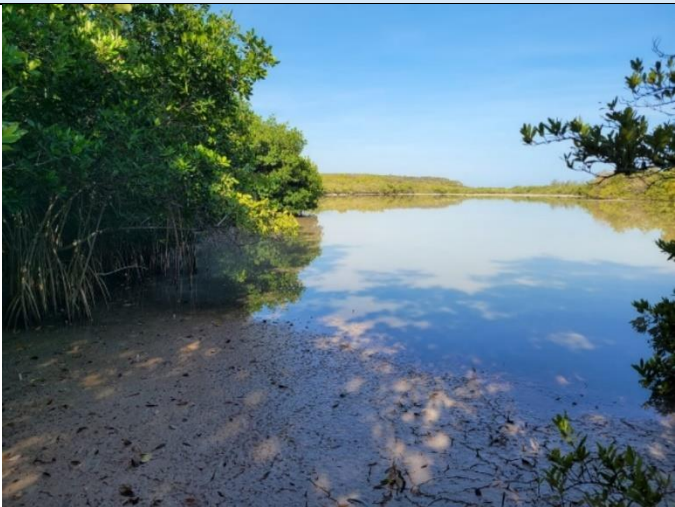
Sample Location	GPS Coordinates	Description	
		Dry Season (April 2024)	Wet Season (September 2024)
WQ1	18°29'19.26"N 77°34'28.59"W	<p>The sample was collected at the eastern end of a pond – reported to have been used as a salt evaporation pond. The boundary of this pond was located approximately 30 feet west of the western end of the Ocean Coral Spring Hotel. The water in the pond appeared turbid and a slight pungent odour was detected at this sampling location. The area to the north of the sampling point was polluted with solid waste associated with anthropogenic activities. Horse manure was also observed along the pathway to the sampling area. The sand in this area was waterlogged, while the entire pond was bordered with mangroves.</p> <p>The sample collected appeared to be pale yellow-grey, translucent with a slight pungent odour as well as settled and suspended particles.</p>	<p>The general description of the sampling location was similar to that observed in the dry season. However, leaf litter was seen on the surface of the water during this sampling exercise and there was a notable increase in the volume of water present within the pond</p> <p>The sample collected was pale brown, translucent, foamy and had small dark animals present within it.</p>

<p>Environmental Conditions: Cool, overcast, light rainfall</p>

<p>Environmental Conditions: Cool, sunny with clear skies</p>	
WQ2	18°29'21.15"N 77°34'39.06"W	<p>The sample was collected from the mid-section of a large pond. The pond area around the sampling point was approximately 280 feet wide. Small channels approximately 1.5 feet deep were observed adjacent to the sampling location. Cranes and other birds were observed at this sampling area. Bird tracks were also observed on the waterlogged sand. Mangroves were observed bordering the pond area.</p> <p>The sample collected appeared pale brown-grey and translucent with settled and suspended particles. Small black bugs were observed in the sample also.</p>	<p>The general description of the sampling location was similar to that observed in the dry season. However, leaf litter was seen on the surface of the water during this sampling exercise and there was a notable increase in the volume of water present within the pond.</p> <p>The sample collected was pale brown, translucent, foamy and had small dark animals present within it.</p>

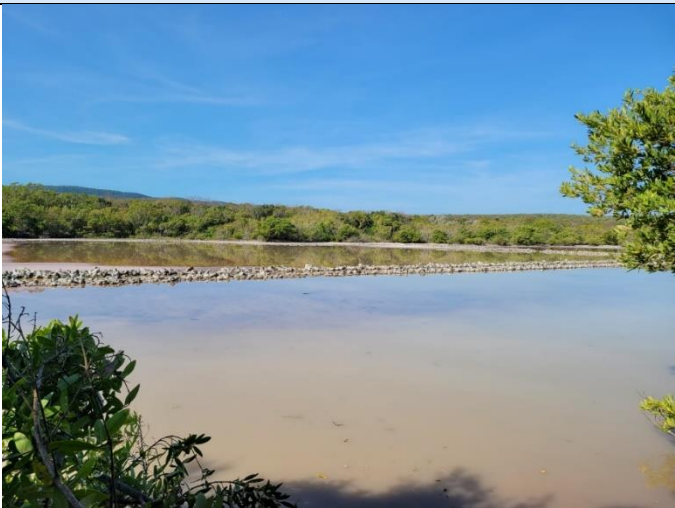
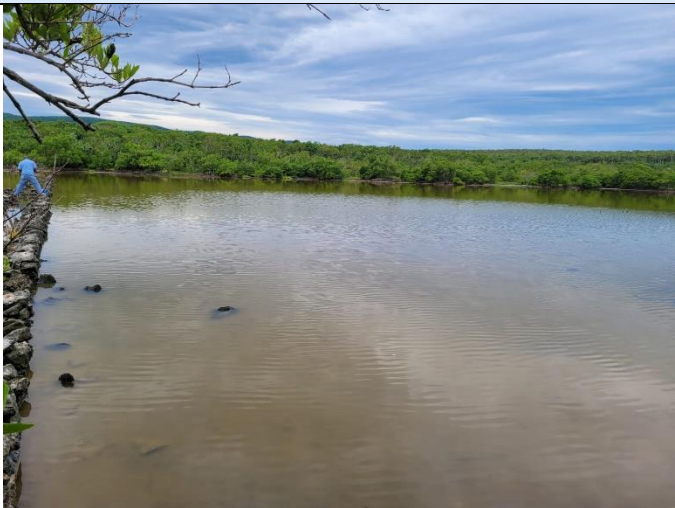
<p>Environmental Conditions: Cool, sunny with clear skies</p>

<p>Environmental Conditions: Cool, sunny with clear skies</p>
WQ3	18°29'22.10"N 77°34'43.42"W	<p>The sample was taken close to the western end of the pond. This area was noticeably dryer, and water levels were lower than the mid and eastern end of the pond. A pungent odour was detected at this location. As per the other sampling locations, mangroves bordered the pond area, and some crystalline/salt particles were observed on the dryer sandy areas.</p> <p>The sample collected appeared pale yellow, translucent with a slight pungent odour and small black bugs .</p>	<p>The sample was taken at the western end of a large open pond. Similar to the sample collected in the dry season, mangroves bordered this sampling area, however, there was no odour detected during this exercise. Additionally, birds were observed at this location.</p> <p>The sample collected appeared brown and translucent.</p>

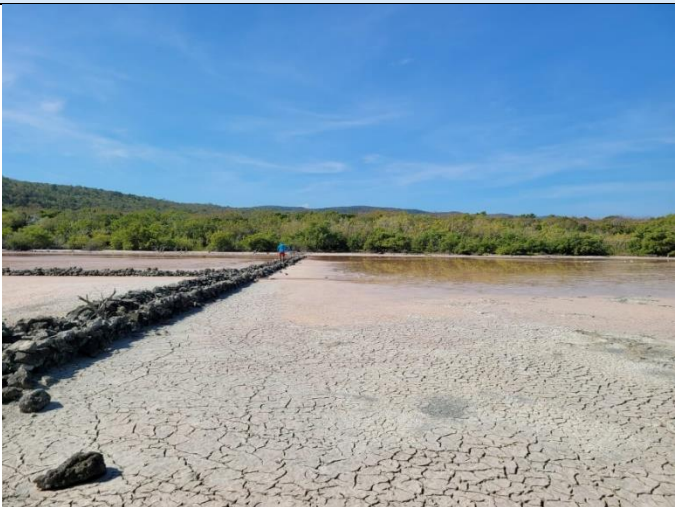
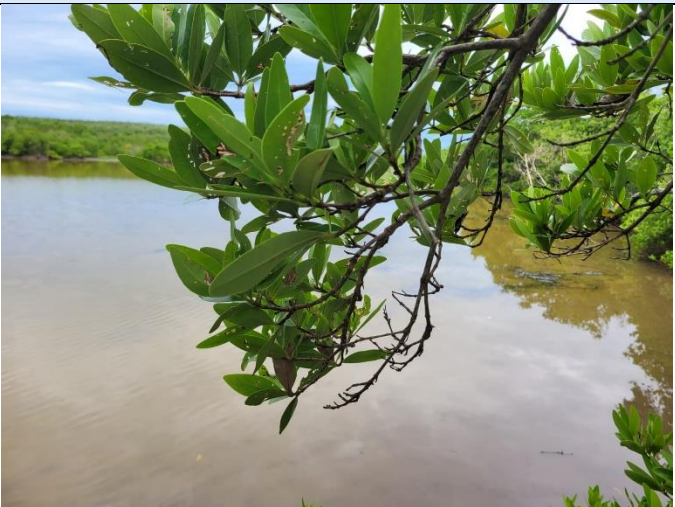
<p>Environmental Conditions: Cool, sunny with clear skies.</p>

<p>Environmental Conditions: Cool, broken clouds, sun starting to rise.</p>
WQ4	18°29'29.00"N 77°34'40.00"W	<p>The sample was collected in the marine environs north of the proposed project area. The sample was collected approximately 300 ft north of a beach. The water at this location was extremely clear and a shallow reef structure that was approximately 5-6 feet deep was observed at the bottom of this sampling area. Small bubbles were seen on the surface of the water body. The Ocean Coral Spring/ Eden Bay Hotels were seen towards the east of the sampling location while Hotel Riu (Aquarelle) and cruise ships docked at the Falmouth Cruise Ship Pier were seen clearly towards the west of the sampling area.</p>	<p>The general description of the sampling location was similar to that observed in the dry season.</p> <p>The sample collected was clear and colorless.</p>

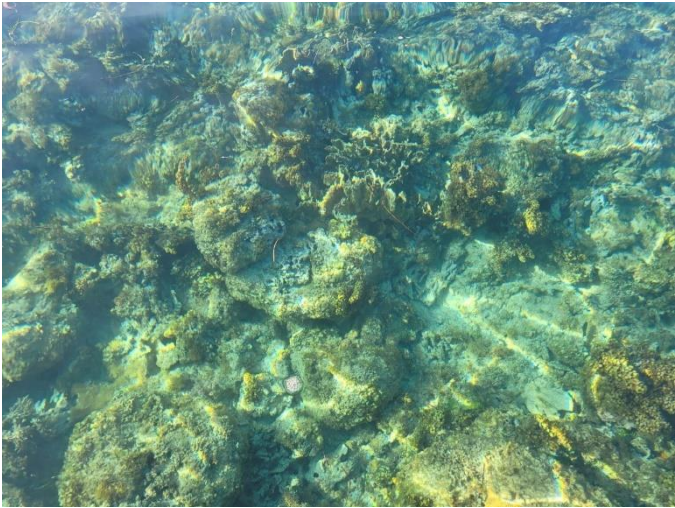
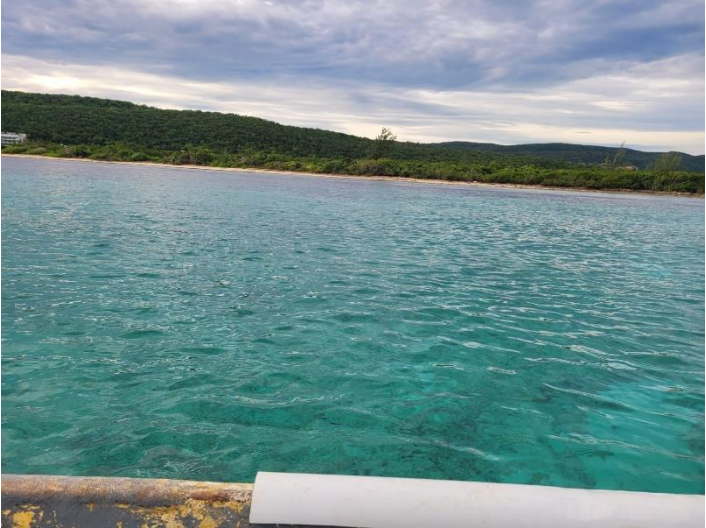
Sample Location	GPS Coordinates	Description	
		Dry Season (April 2024)	Wet Season (September 2024)
		<p>The sample collected appeared clear and colourless.</p>

<p>Environmental Conditions: Cool, sunny with clear skies.</p>

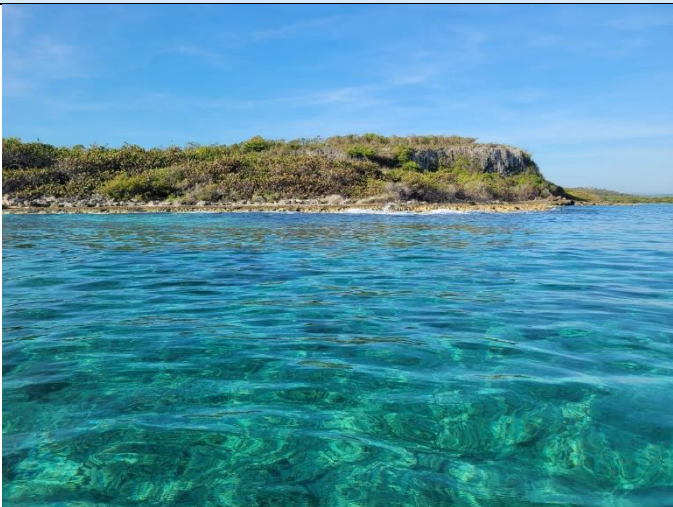
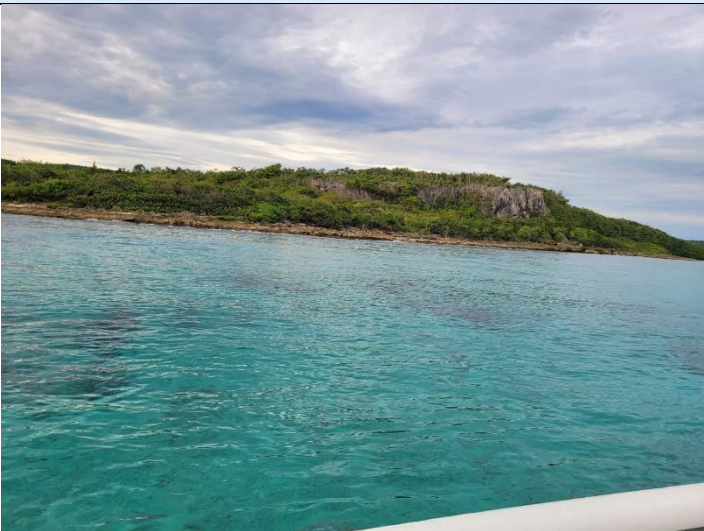
<p>Environmental Conditions: Cool, broken clouds, sun rising</p>
WQ5	18°29'27.00"N 77°34'56.00"W	<p>The sample was collected in the marine environs north of the proposed project area. The sample was collected approximately 100 ft north of a limestone outcrop. The water at this location was extremely clear and a shallow reef structure that was approximately 7 feet deep was observed at the bottom of this sampling area. The Ocean Coral Spring/ Eden Bay Hotels were seen towards the east of the sampling location while Hotel Riu (Aquarelle) and cruise ships docked at the Falmouth Cruise Ship Pier were seen clearly towards the west of the sampling area.</p> <p>The sample collected at this location appeared clear and colorless</p>	<p>The general description of the sampling location was similar to that observed in the dry season.</p> <p>The sample collected was clear and colorless.</p>

<p>Environmental Conditions: Cool, sunny with clear skies.</p>

<p>Environmental Conditions: Cool, broken clouds, sun rising</p>
WQ6	18°29'23.00"N 77°35'11.00"W	<p>The sample was collected in the marine environs north of the proposed project area. The sample was collected approximately 350 ft north of the center of a limestone bluff. The water at this location was extremely clear and a shallow reef structure that was approximately 7 feet deep was observed at the bottom of this sampling area. A brown pelican was observed in this area and small amounts of grassy matter was seen on the surface of this sampling location. A boat was observed towards the north of the sampling area. The Ocean Coral Spring/ Eden Bay Hotels were seen towards the east of the sampling location while Hotel Riu (Aquarelle) and cruise ships docked at the Falmouth Cruise Ship Pier were seen clearly towards the west of the sampling area.</p>	<p>The general description of the sampling location was similar to that observed in the dry season. However, no pelican or grassy matter was seen during this sampling exercise.</p> <p>The sample collected was clear and colorless.</p>

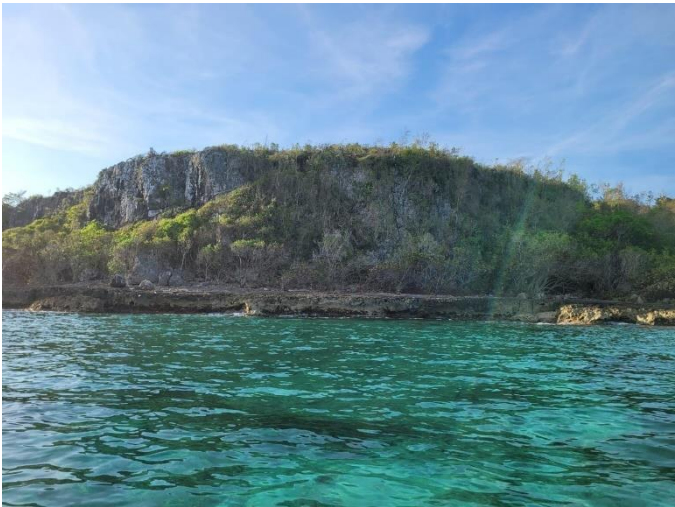
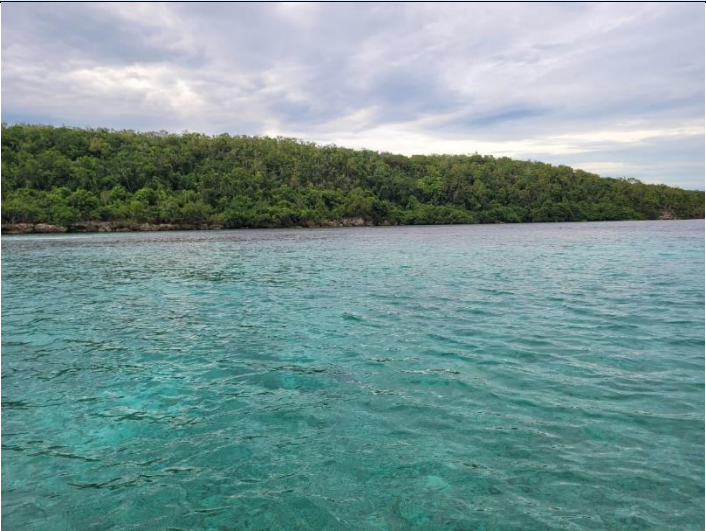
Sample Location	GPS Coordinates	Description	
		Dry Season (April 2024)	Wet Season (September 2024)
		<p>The sample collected at this location appeared clear and colourless.</p>

<p>Environmental Conditions: Cool, sunny with clear skies.</p>

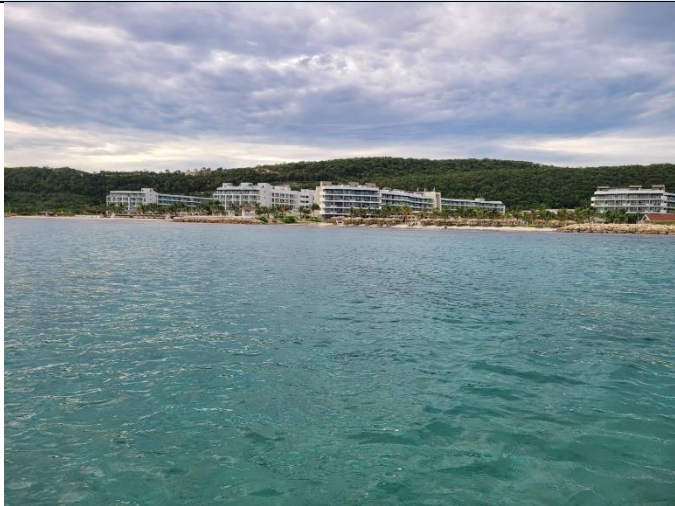
<p>Environmental Conditions: Cool, broken clouds, sun beginning to rise</p>
WQ7	18°29'27.00"N 77°34'22.00"W	<p>The sample was collected in front of a groyne structure at the Ocean Coral Spring Hotel. Natural debris was observed on the surface of this sampling area. The water at this location was clear and a shallow reef structure that was approximately 7 feet deep was seen at the bottom of the sampling area. Jackfish were seen nearby to the sampling area. This sampling area was north-east of proposed project area and approximately 300 ft in front of the Ocean Coral Spring Hotel beach.</p>	<p>The general description of the sampling location was similar to that observed in the dry season. However, no fish were observed during the sampling exercise and very few persons were seen bathing.</p> <p>The sample collected was clear and colorless.</p>

Sample Location	GPS Coordinates	Description	
		Dry Season (April 2024)	Wet Season (September 2024)
		<p>The sample collected at this location appeared clear and colorless.</p>

<p>Environmental Conditions: Cool, broken clouds, sun beginning to rise</p>
WQ8	18°29'34.44"N 77°34'44.39"W	<p>The sample was collected in the marine environs north of the proposed project area. The sample was collected approximately 900 ft north of a beach. The water at this location was extremely clear and the sandy bottom interceded with rocks approximately 18 feet deep was clearly seen. The surface of the water at this location was free from any debris. The Ocean Coral Spring/ Eden Bay Hotels were seen towards the east of the sampling location while Hotel Riu (Aquarelle) and cruise ships docked at the Falmouth Cruise Ship Pier were seen clearly towards the west of the sampling area.</p>	<p>The general description of the sampling location was similar to that observed in the dry season. However, grassy material was seen on the surface of the water body.</p> <p>The sample collected was clear and colourless.</p>

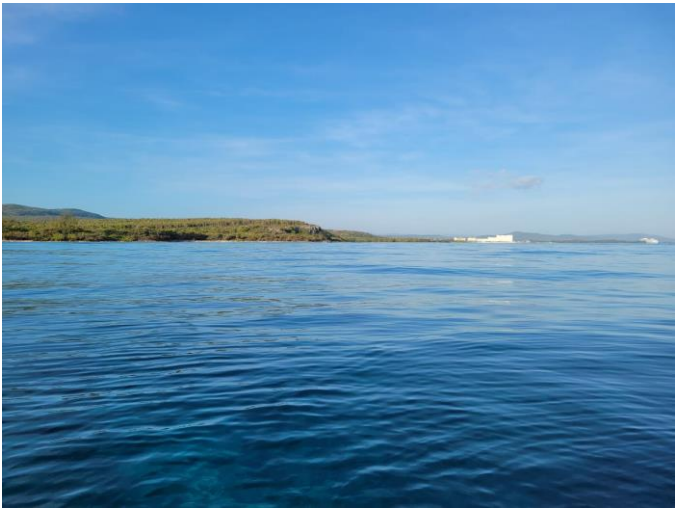
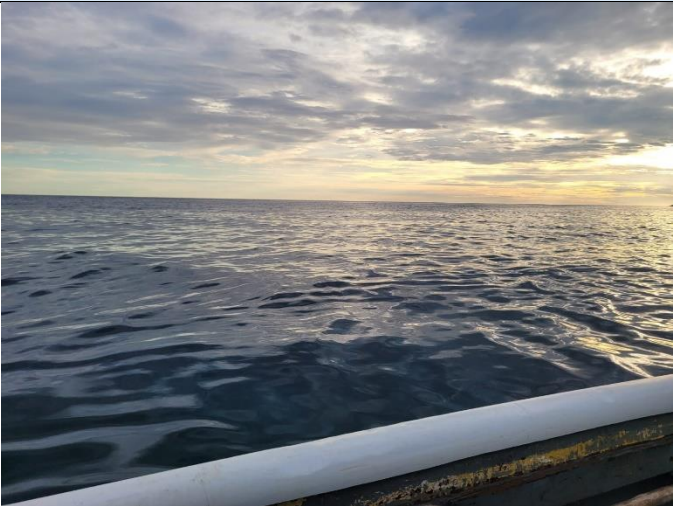
Sample Location	GPS Coordinates	Description	
		Dry Season (April 2024)	Wet Season (September 2024)
		<p>The sample collected appeared clear and colourless.</p>

<p>Environmental Conditions: Cool, sunny with clear skies.</p>

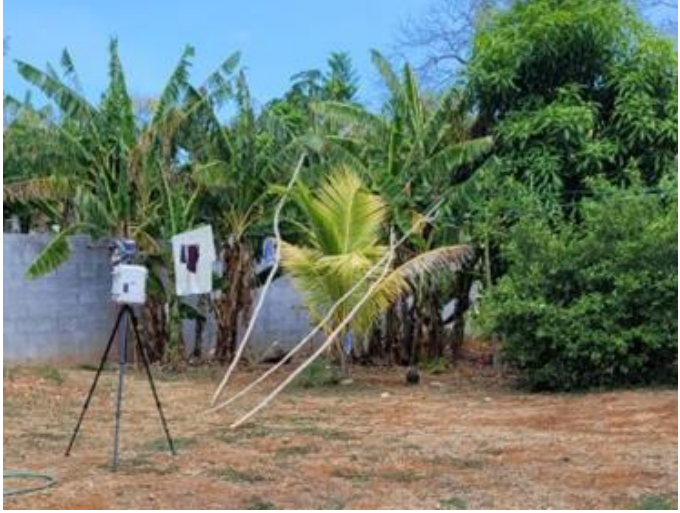
Sample Location	GPS Coordinates	Description of Sampling Location
Dry Season (April 2024)		
AQ1	18°29'0.70"N 77°35'5.70"W	<p>This air quality sampling location was located nearby the south-western end of the proposed property location. This sampling area was located in the yard of a residential home. Fruits and decorative trees were seen nearby to the pump location. An unfinished house was located to the west of the air quality sampling location. The ground was sparsely vegetated. A few concrete blocks and ply boards were seen towards the south of the pump set up location. Gravel and a dirt heap was seen approximately 20 feet north west of the pump set up location.</p>

<p>Environmental Conditions: Moderate winds, sunny & cool.</p>
AQ2	18°28'40.90"N 77°34'50.50"W	<p>This air quality sampling location was located approximately 300 meters south-east of the south-eastern proposed project boundary in an established community area. The pump was set up north-east of a small apartment and north-west of an unfinished house. Light construction appeared to be taking place towards the west of the air quality location. Towards the north of the pump set up area was densely vegetated</p>

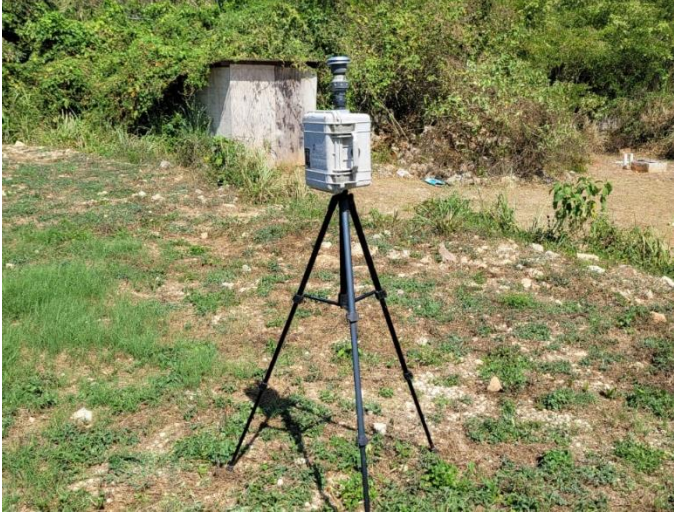
Sample Location	GPS Coordinates	Description of Sampling Location
		<p>and the ground at the pump set up locations was moderately grassed. An asphalt road was located south of the pump set up area. Several parked cars were located north of the pump set up area.</p>

<p>Environmental Conditions: Moderate winds, sunny & cool.</p>
AQ3	<p>18°29'15.80"N 77°34'34.90"W</p>	<p>This air quality sampling station was located close to the north-eastern end of the proposed project boundary. This assessment point was located in a clearing approximately 170 meters west of the western boundary of the Ocean Coral Springs hotel. Sections of the hotel were clearly seen from the pump set up location. The ground was rocky with areas of exposed dirt and gravel. Tall grassy plants and short shrubs were also observed close to the pump set up location. Areas around the pump was moderately vegetated with tall narrow-trunked trees.</p>

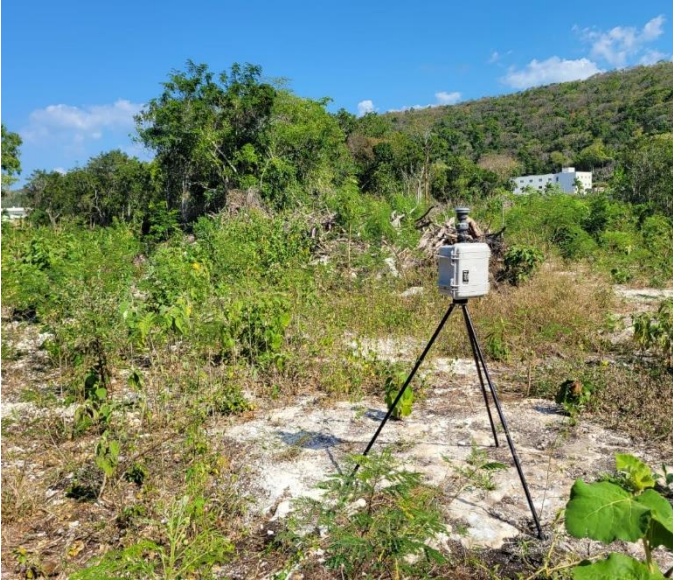
<p data-bbox="756 863 1425 926">Environmental Conditions: Moderate winds, sunny & cool.</p>
AQ4	18°29'17.40"N 77°34'52.90"W	<p data-bbox="735 930 1446 1358">This air quality sampling location was located near to the north-western end of the proposed development boundary. The sampling area was located approximately 300 meters west of a limestone bluff. The pump was placed in an approximately 15-foot-wide pathway; this pathway was lined with moderate vegetation. The ground at this sampling location was sparsely to moderately vegetated with grasses and short shrubs. There were rocks embedded in the ground, however, there were also pockets of exposed dirt and gravel.</p>

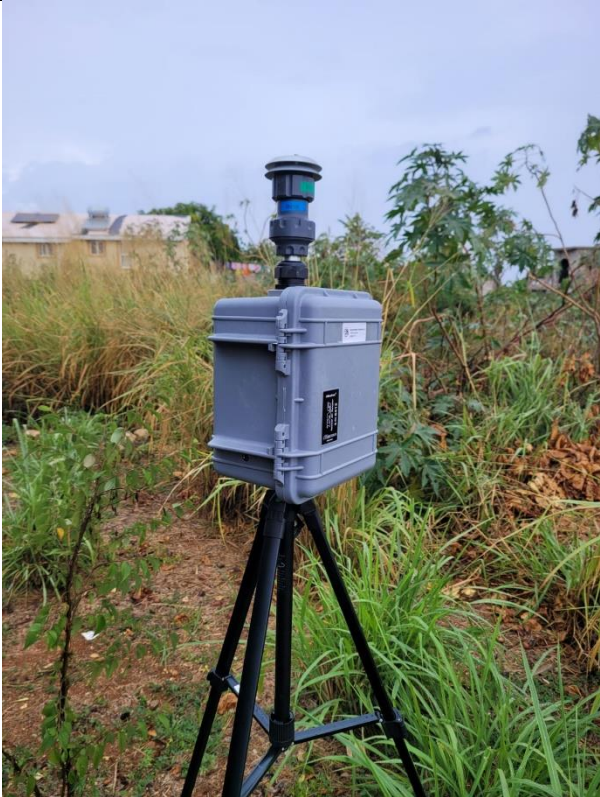
<p data-bbox="755 877 1425 951">Environmental Conditions: Moderate winds, sunny & cool.</p>
Wet Season (September 2024)		
AQ1	18°28'58.14"N, 77°35'4.46"W	<p data-bbox="735 982 1446 1411">This air quality sampling location was located approximately 100 meters south-east of the south-western end of the proposed property location. This sampling area was located in the yard of a unoccupied residential home on a gently sloping hill. Fruit trees and tall grasses were seen near to the pump location. An area where items were burned was seen to the northwest of the pump set up area. The main roadway was clearly observed approximately 30 meters to the west of the pump set up location and approximately 10 meters to the south of the pump set up area.</p>

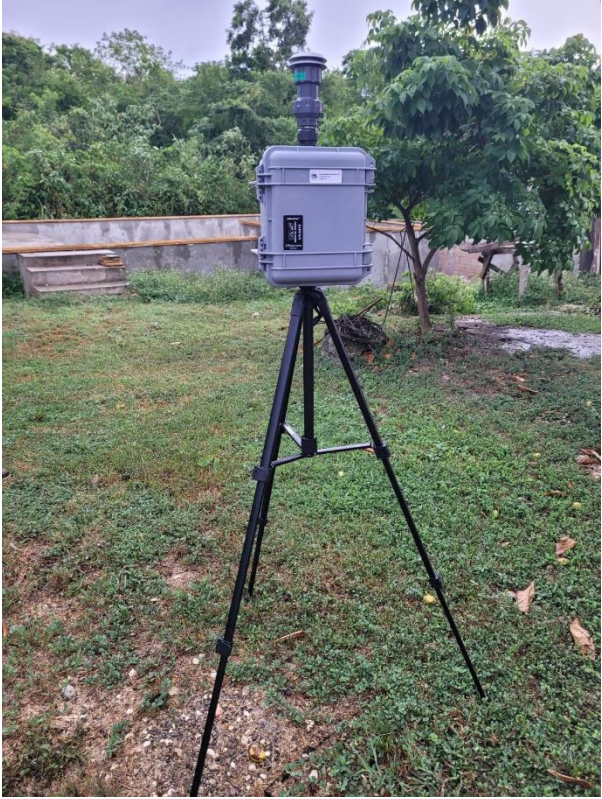
<p data-bbox="792 1077 1388 1108">Environmental Conditions: Overcast, humid.</p>
AQ2	18°28'41.59"N. 77°34'51.37"W	<p data-bbox="734 1115 1446 1394">This air quality sampling location was located approximately 300 meters south-east of the south-eastern proposed project boundary in an established community area. The pump was set up in a grassed area north of a residential dwelling. An unfinished pool and heavily vegetated areas were located north of the pump set up area. A large tree, as well as a bird cage was located to the east of the pump set up area.</p>

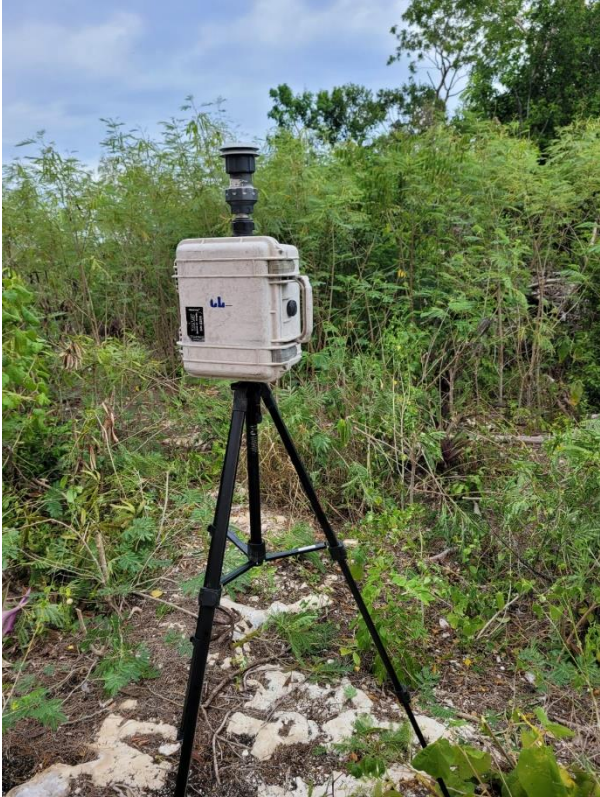
<p data-bbox="760 1077 1419 1146">Environmental Conditions: Light sporadic rainfall, overcast, humid.</p>
AQ3	18°29'15.80"N 77°34'34.90"W	<p data-bbox="747 1150 1435 1535">This air quality sampling station was located close to the north-eastern end of the proposed project boundary. This assessment point was located in a clearing approximately 170 meters west of the western boundary of the Ocean Coral Springs hotel. Sections of the hotel were clearly seen from the pump set up location. The ground was rocky with areas of exposed dirt and gravel. Tall grassy plants and short shrubs were also observed close to the pump set up location. Areas around the pump were heavily vegetated with tall narrow-trunked trees.</p>
