ENVIRONMENTAL AND SOCIAL ASSESSMENT FOR PROPOSED HOUSING DEVELOPMENT- CORAL SPRING VILLAGE 2 TRELAWNY

Resubmitted: October 14, 2024

Draft Final Report

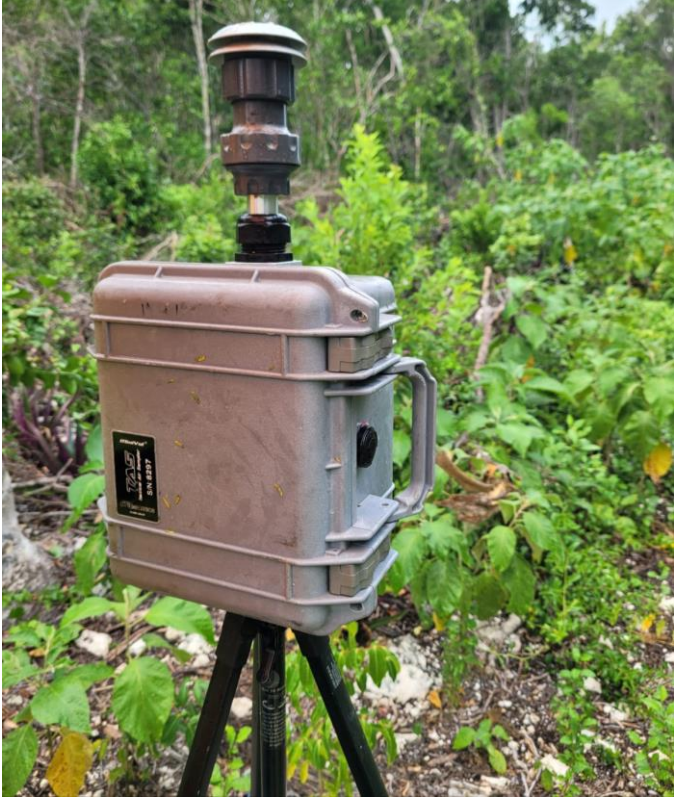
<p data-bbox="760 1077 1421 1144">Environmental Conditions: Light sporadic rainfall, overcast, humid.</p>
AQ4	<p data-bbox="511 1346 703 1409">18°29'17.40"N 77°34'52.90"W</p>	<p data-bbox="743 1186 1437 1535">This air quality sampling location was located near to the north-western end of the proposed development boundary. The sampling area was located approximately 300 meters west of a limestone bluff. The pump was placed in an approximately 15-foot-wide pathway; this pathway was lined with moderate vegetation. The ground at this sampling location was moderately vegetated with grasses and short shrubs. There were rocks embedded in the ground, however, there were also pockets of exposed dirt and gravel.</p>

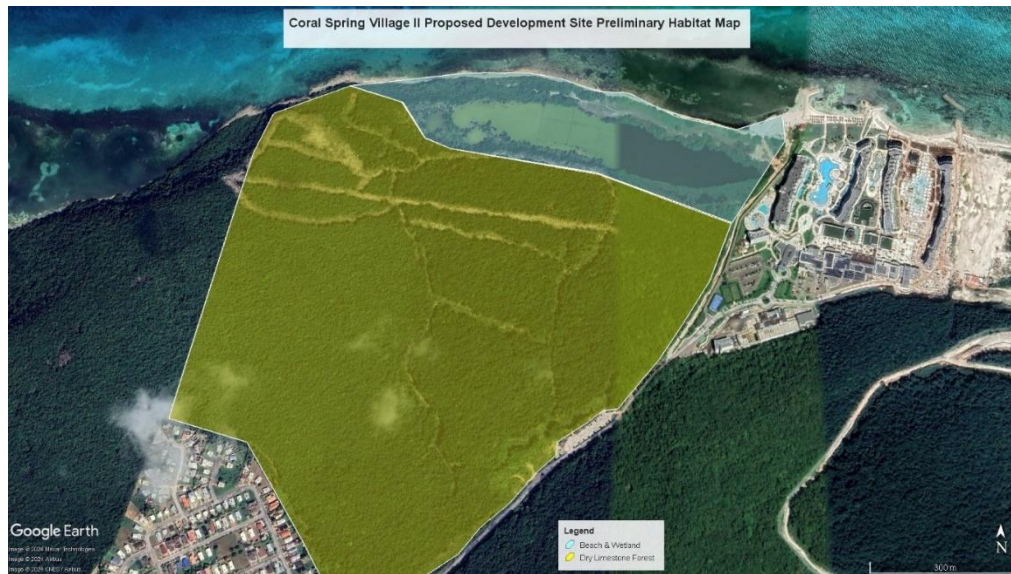
The vegetation types observed within the proposed development site was typical of coastal formations along the north coast of Jamaica. The coastal communities include beach, dune, Salinas, mangroves, coastal woodlands and dry limestone forest. The development site however is predominantly dry limestone forest with narrow transitional areas where the dry limestone forest intersects other ecosystems or habitat types, particularly beach and wetland (see Figure 4-20).

Figure 4-21: General habitat types at proposed development site (Coral Spring Village II)

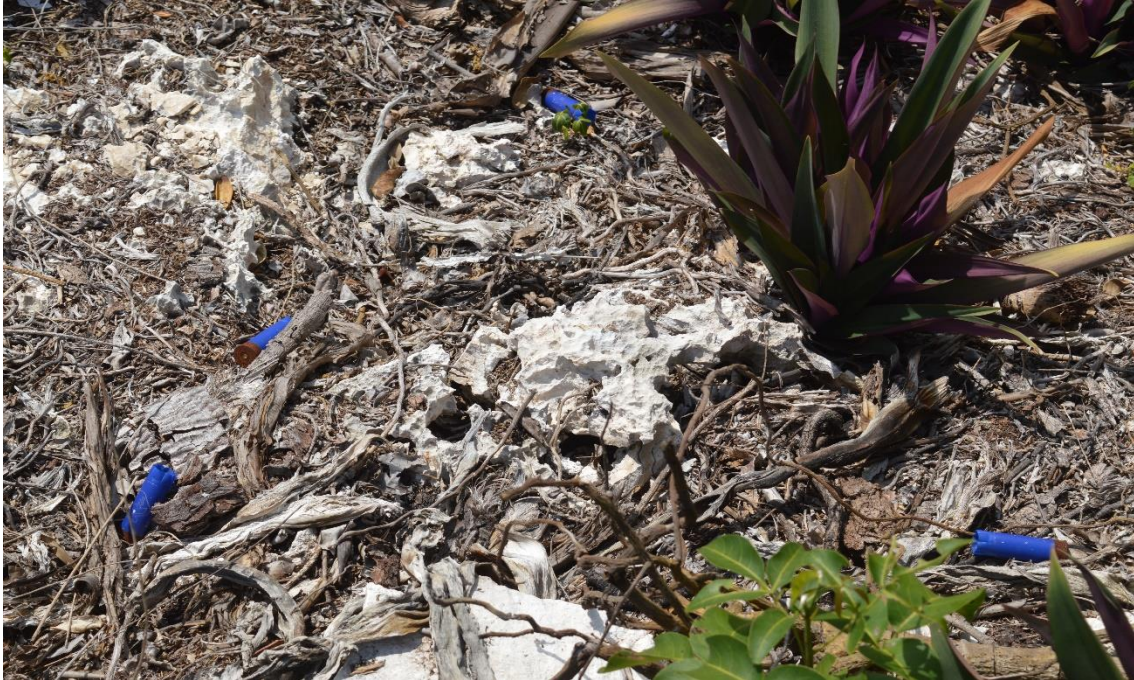
Primack (2000) defines sustainable development as the achievement of economic growth that meets current and future human needs for resources and employment while mitigating its impact on biological diversity. During the assessment of the development site, it was evident that anthropogenic pressures were adversely affecting the existing plant biodiversity and the surrounding ecosystems. One of the primary challenges observed was habitat fragmentation resulting from the development of multiple clearings, seemingly forming a network of roads (see Appendix 8.1 – Plates 14-21). Additionally, the area appeared to be utilized as a bird shooting site, as indicated by several sightings of spent shells (see Figure 4-26).

Figure 4-27: Spent shells associated with bird shooting.

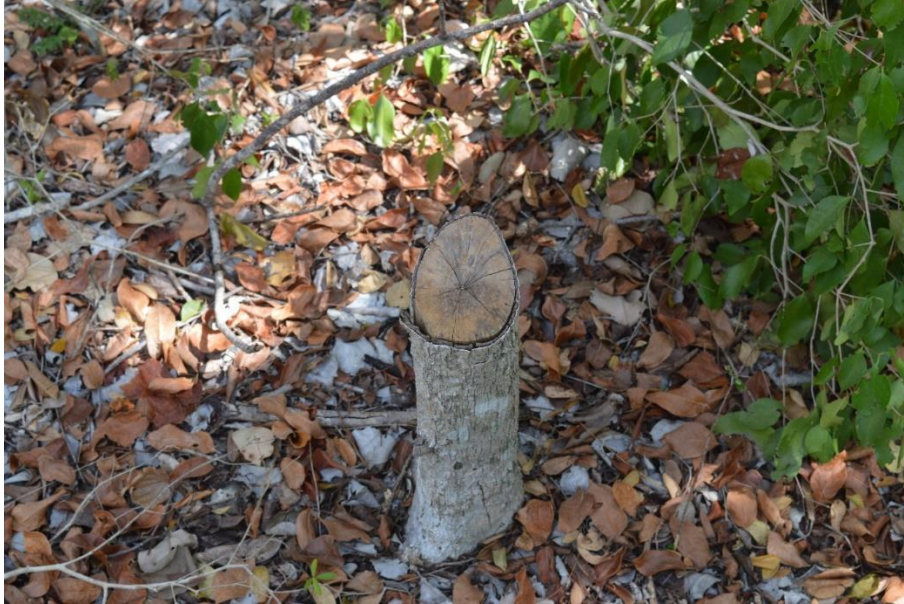
Observations revealed several young trees with their trunks cut, branches stripped, and left as refuse, along with small stacks of cut trunks scattered throughout the clearings running from east to west of the proposed development site (see Figure 4-27). The trunks positioned along the edges of these clearances (see Figure 4-28) may represent opportunistic cuttings, taking advantage of access points into the dry limestone forest. Further north, towards the wetlands, similar cuttings appear to have been made opportunistically, possibly utilizing older clearances also frequented by bird shooters. Additionally, the presence of exotic species was noted primarily in areas adjacent to the roadway bordering the proposed development site to the east, as well as in areas where vegetation had been recently cleared.

Figure 4-28: Evidence of trees being harvested/cleared.

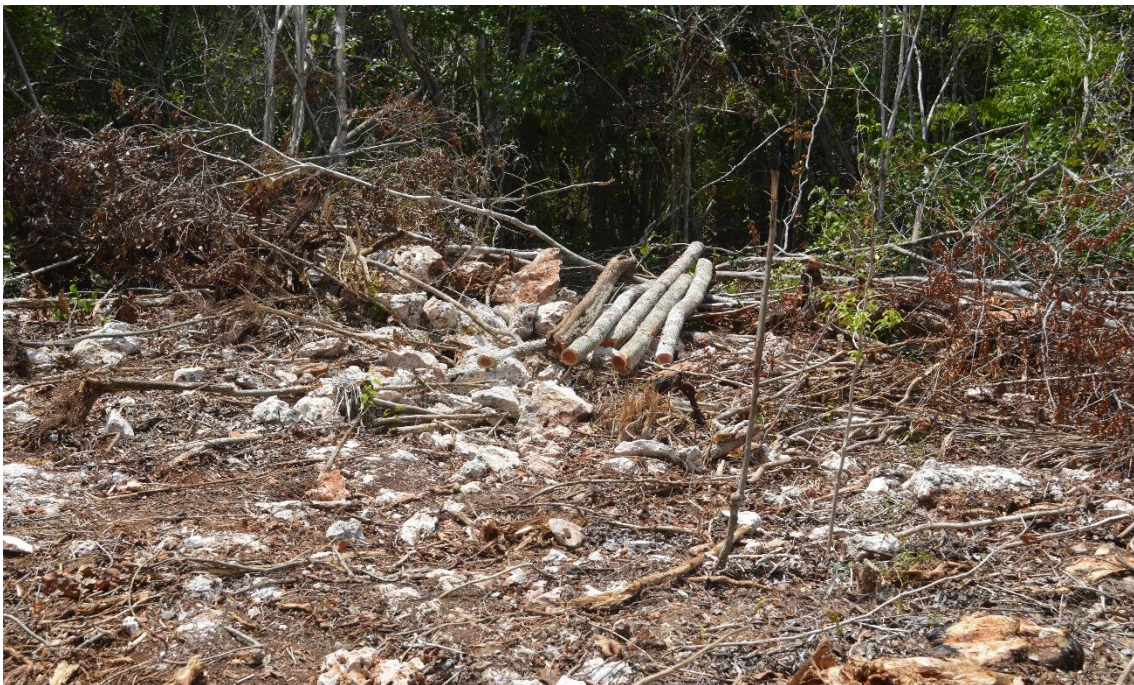
Figure 4-29: Posts cut and stored along clearances.

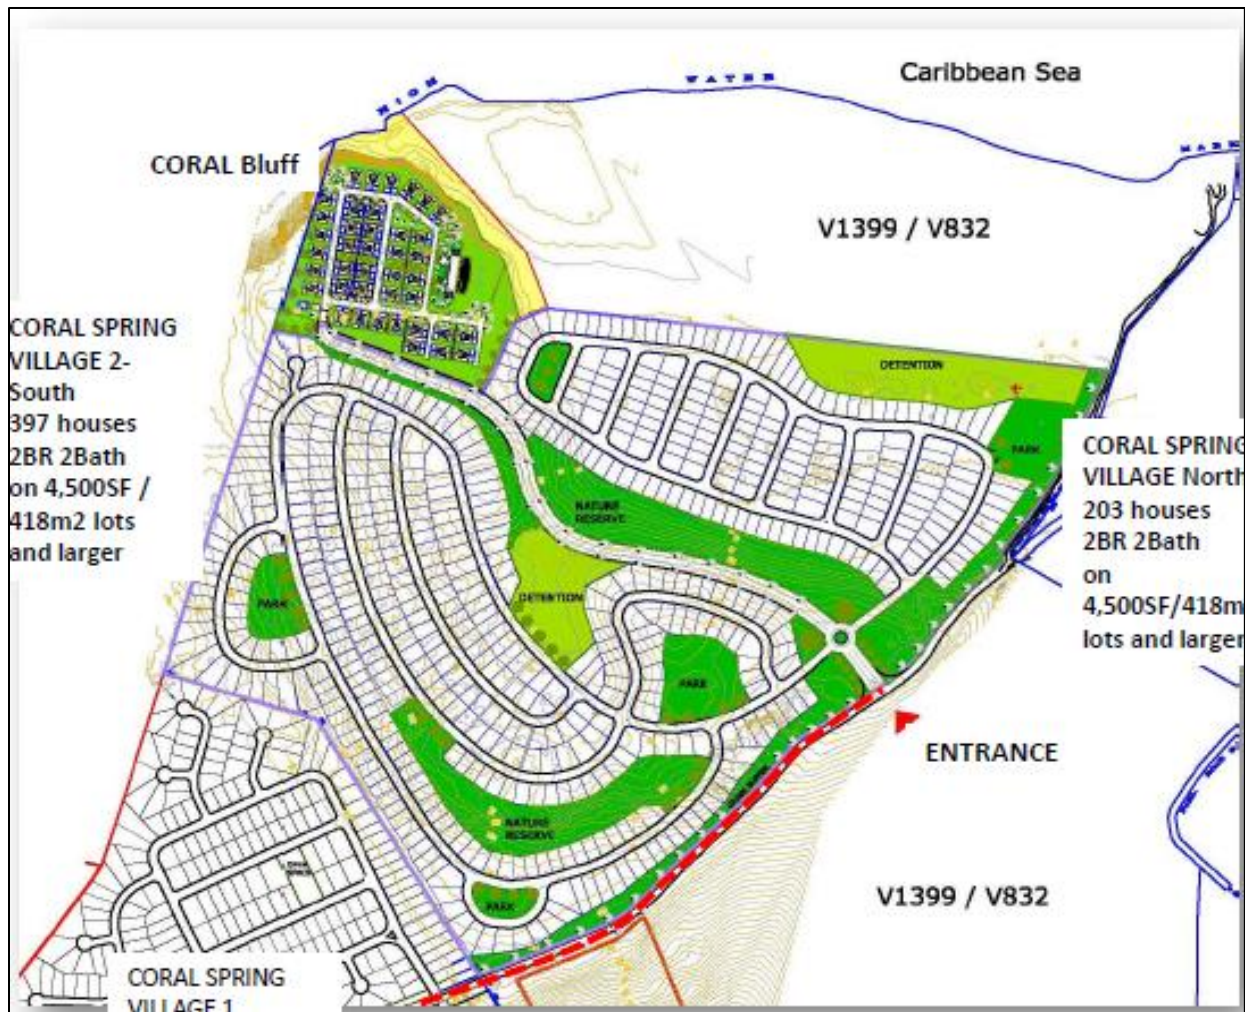
The site is located approximately 7 km due east of the town of Falmouth and 7.5 km due west of Duncans, Trelawny. It is bordered by the Coral Spring-Mountain Spring Protected Area (CSMSPA). The proposed development site spans approximately 0.7 km² with a perimeter of about 3.22 kilometres, and encompasses distinct habitat zones, characterized by its vegetation types. To the north, disturbed limestone woodlands transition into coastal limestone forests to the south. These habitats gradually shift to more pristine forested areas at higher elevations in the northeast and southwest, where human disturbance diminishes (see Figure 8-1 below).

Figure 8-1: Subdivision Layout Plan

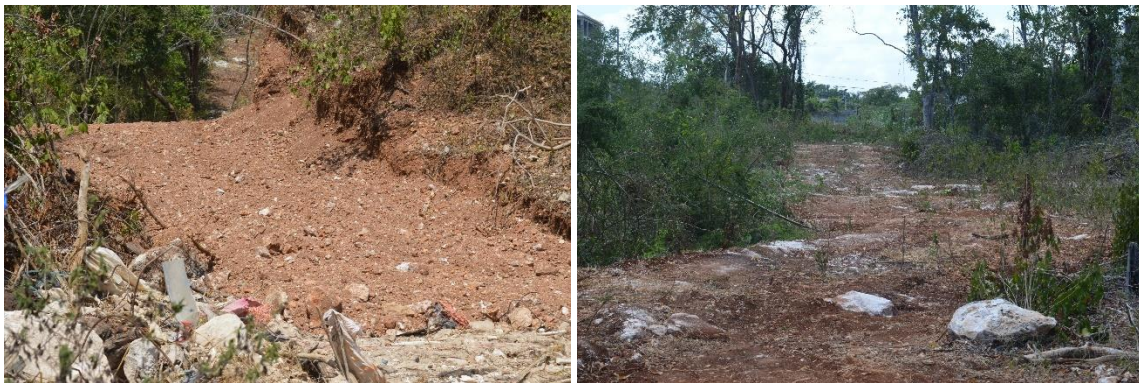
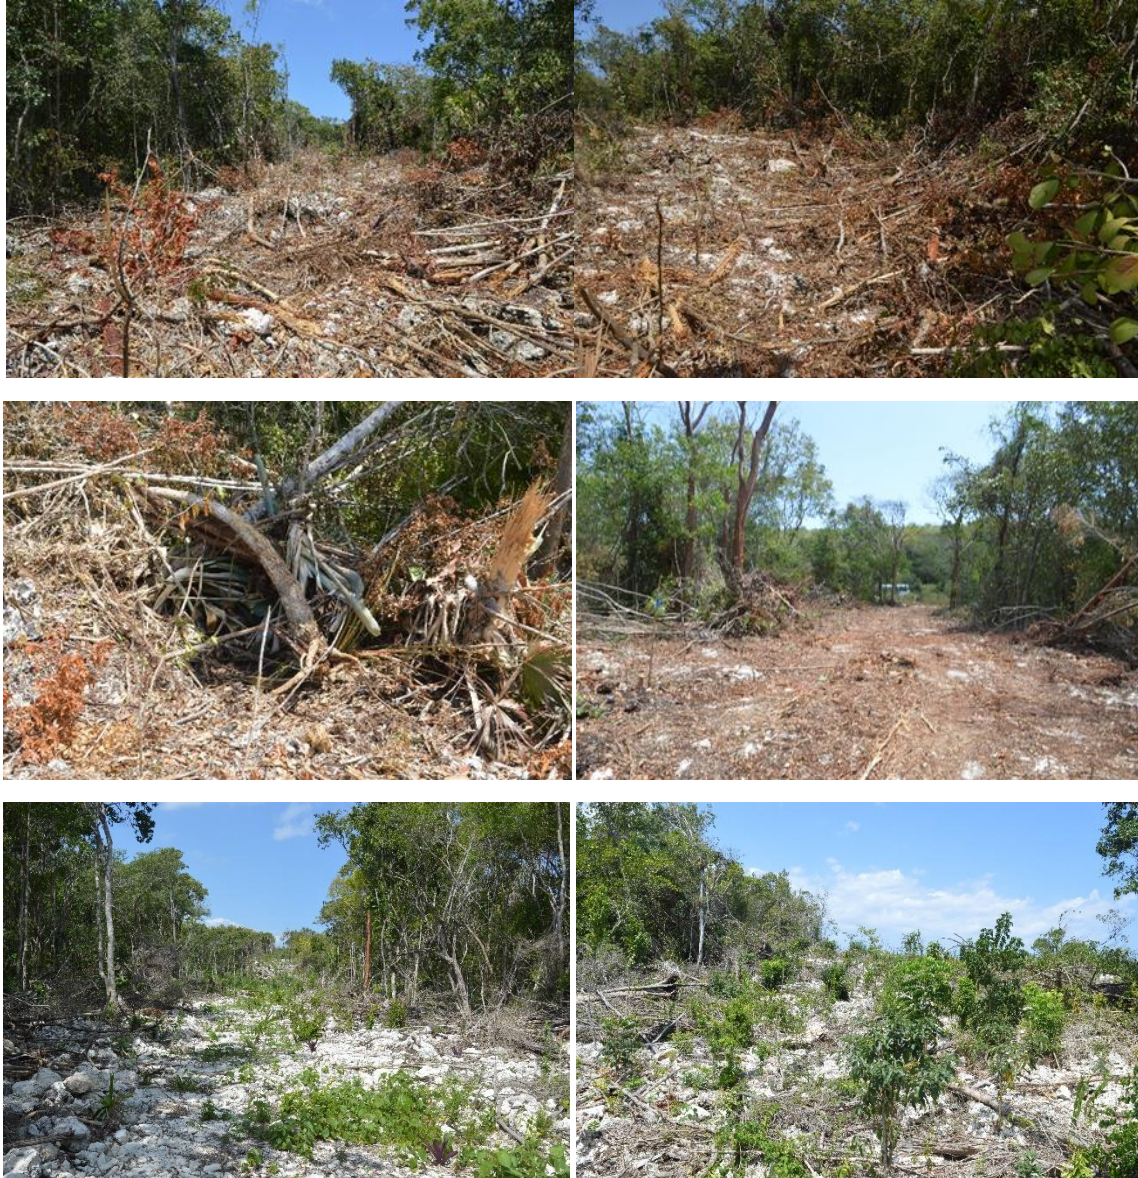
PLATE 14-21

Images showing areas cleared throughout the proposed development site.
